Project Name	Brown's Creek Stream Visual Assessment & Geomorphic Survey	Date	05/2/2023
To / Contact info	BCWD Board of Managers		
Cc / Contact info	Karen Kill, District Administrator		
From / Contact info	Mike Majeski & Dan Mosing		
Regarding	SVAP & Geomorphic Data Assessment and Drone Flight Upstream of Manning Avenue

Stream Visual & Drone Assessments

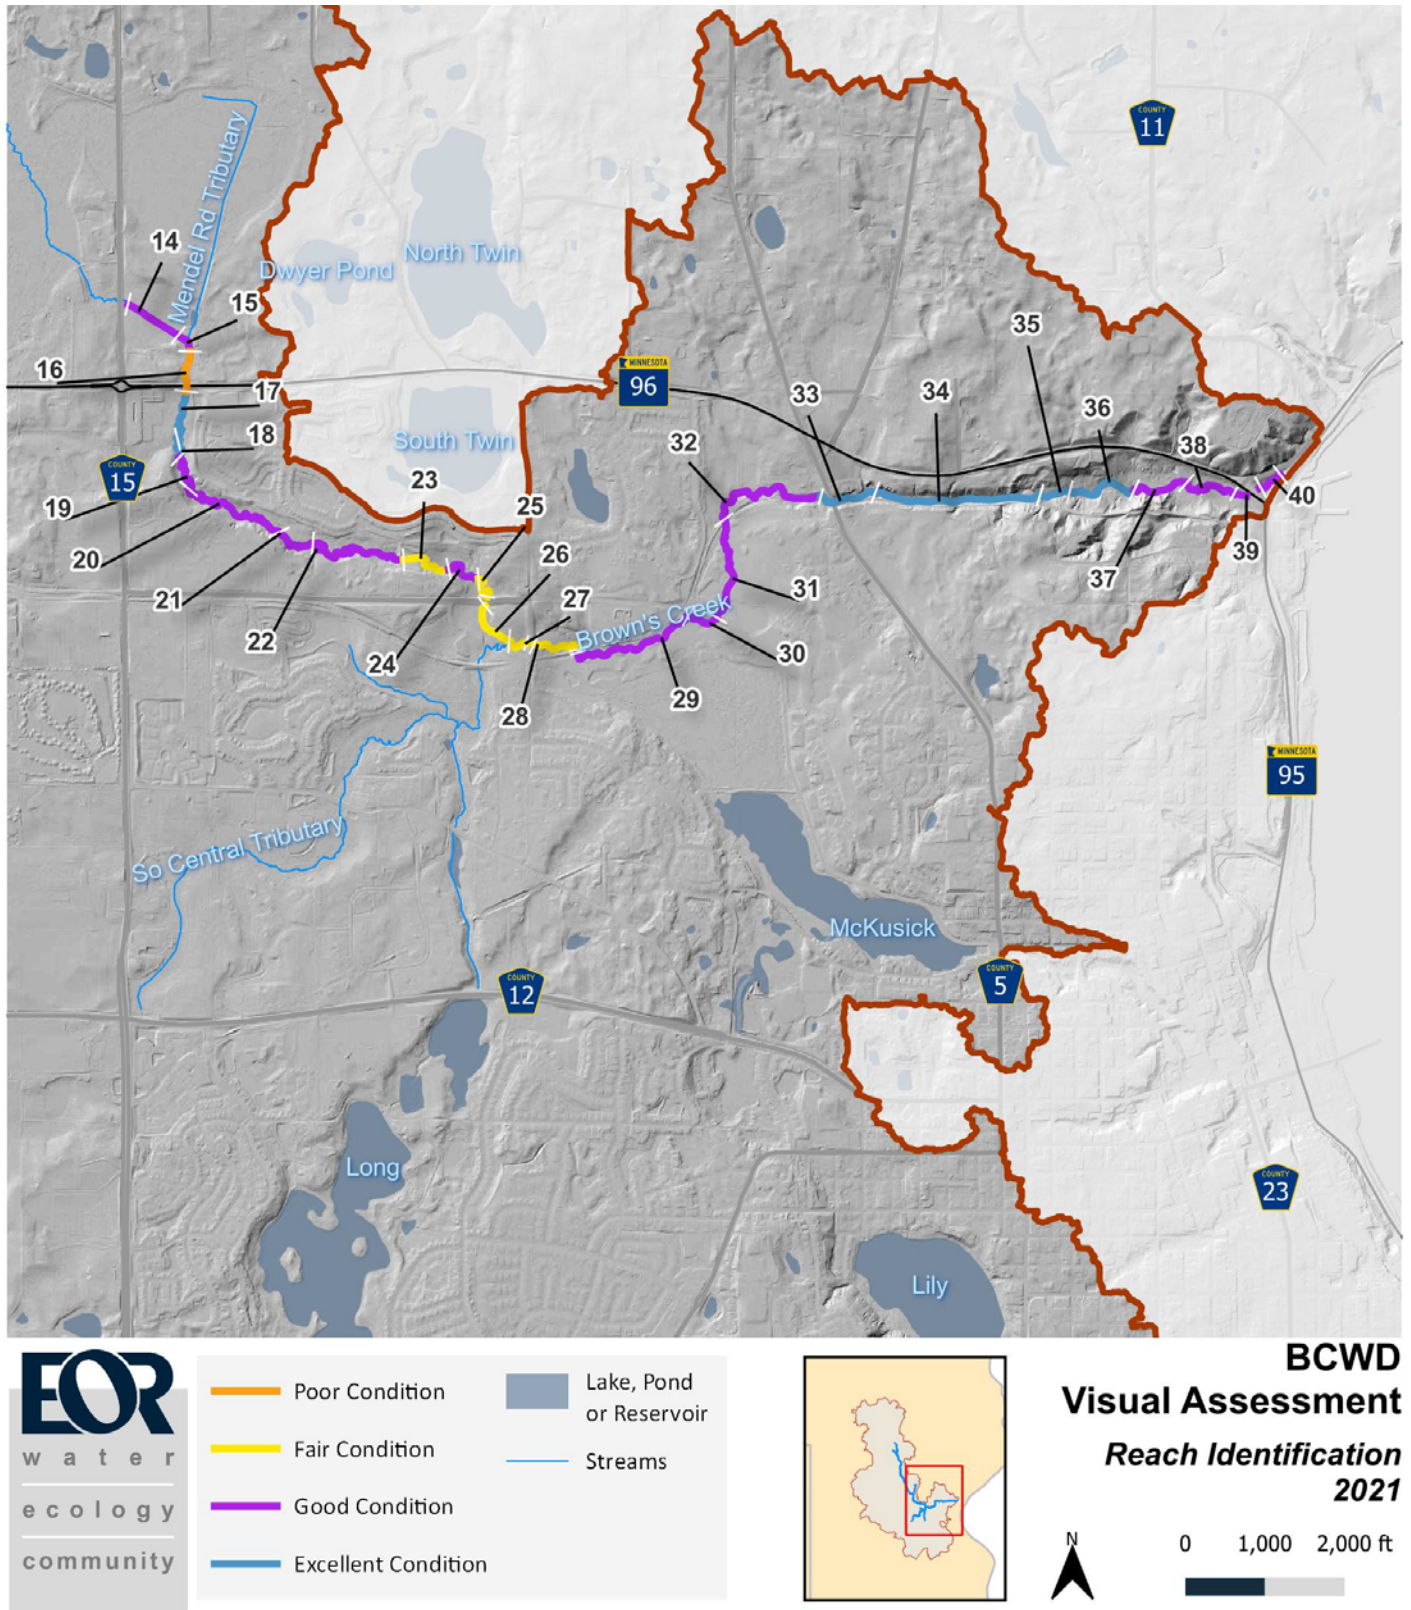
Figure 1. SVAP2 reaches assessed from Manning Avenue to the St. Croix River. Refer to Appendix B for individual reach scores

Each stream reach was assessed by eleven SVAP2 elements (described in Appendix B) and rated with a value of 1 to 10. Generally, a score of 10 is of reference reach quality, a score of 5 has moderate impacts, and a score of 1 indicates the stream is severely impacted. Twenty-eight stream reaches were assessed from Manning Avenue to the St. Croix River (Figure 1). The lowest score of the all the reaches assessed was 4.9. This reach is associated with a private parcel immediately north of Highway 96 where the stream banks have been stabilized with rock riprap and the adjacent riparian corridor was comprised of mowed lawn. Although the stream banks are very stable in this reach, the SVAP2 adversely scores rock riprap due to its negative influence on near-stream habitat such as overhanging vegetation and undercut banks. In addition, the presence of mowed lawn within the floodplain negatively impacts the scores of other elements including riparian vegetation quantity and quality. The highest scores from the assessment included two consecutive reaches downstream of Highway 96 (scores of 9.0) and four consecutive reaches in the Brown's Creek gorge (scores of 9.1). Both areas are located in high quality riparian corridors with diverse native vegetation and very good instream habitat. These sites have stable stream banks, a functional and connected floodplain, and diverse instream habitats with exposed substrates that support a variety of macroinvertebrates. Reaches that scored "Fair" included the creek section recently proposed for stream restoration between McKusick Road and the Brown's Creek State Trail. These reaches contained an incised channel, a disconnected floodplain, eroding banks, and poor riparian vegetation dominated by invasive species including common buckthorn, honeysuckle, and Amur maple. See Appendix B for scores of all 28 reaches assessed.

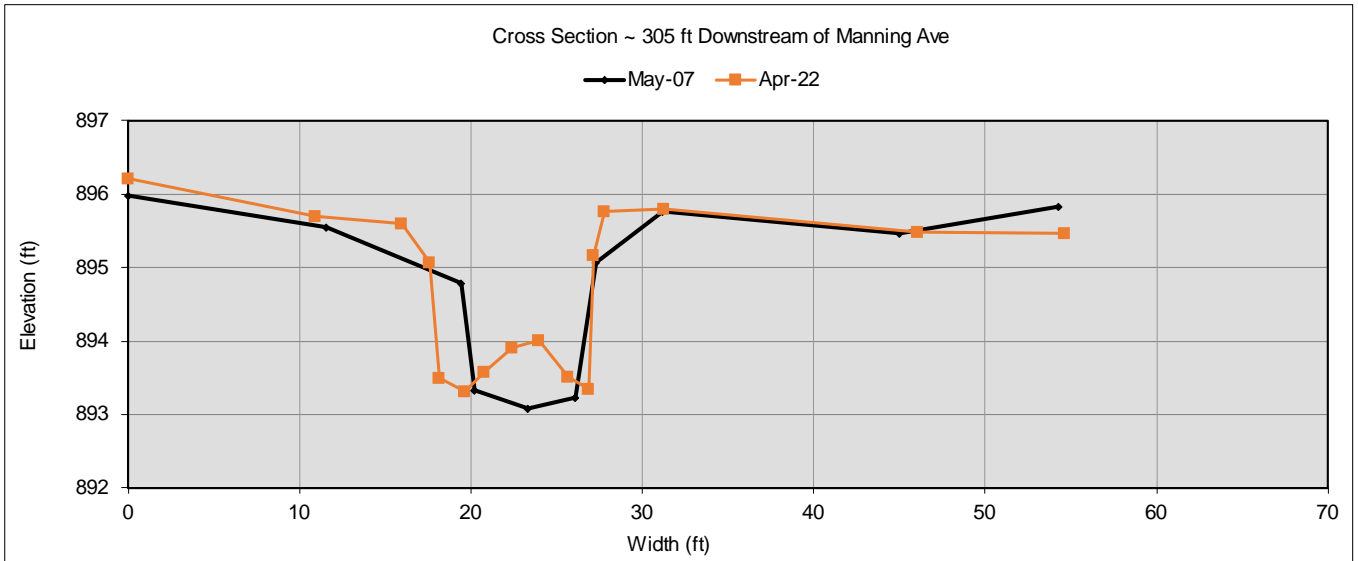
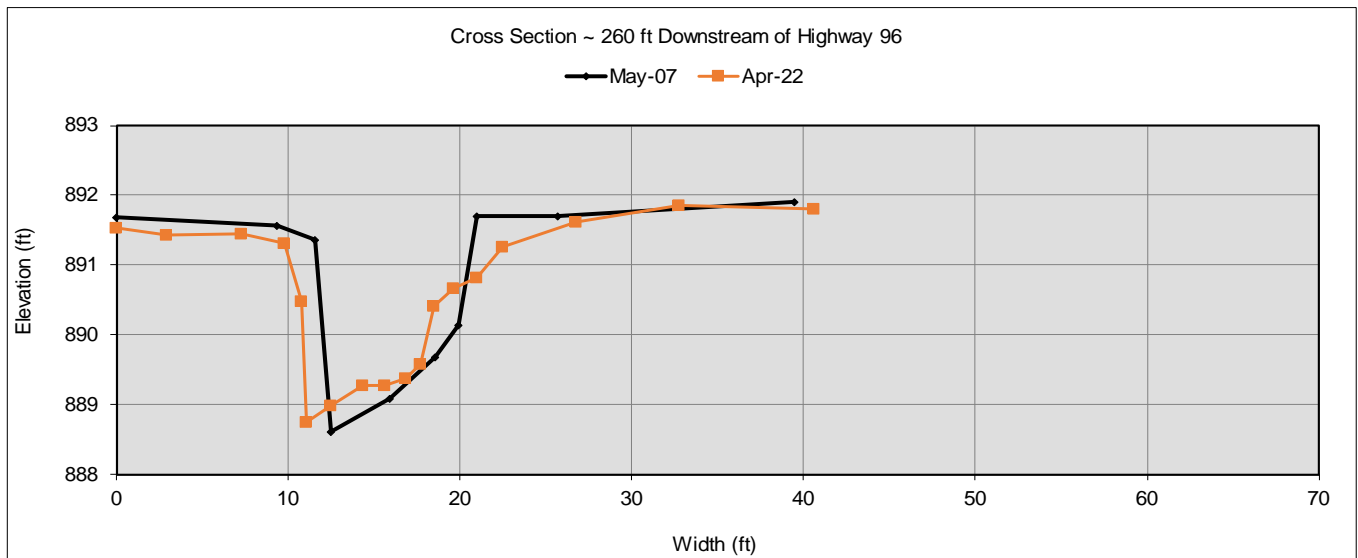
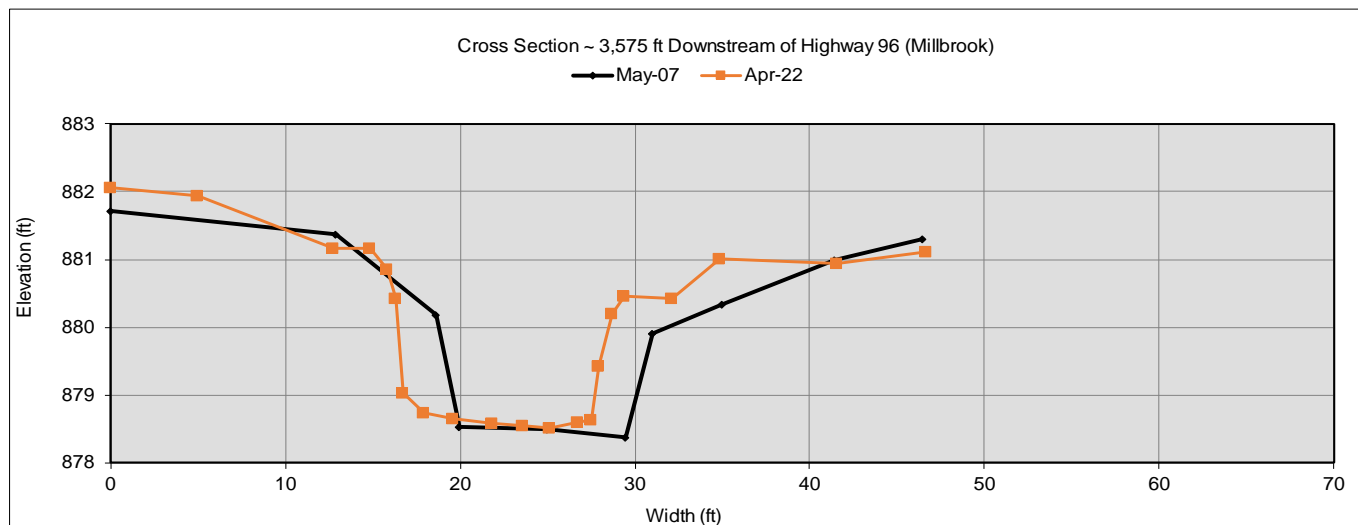
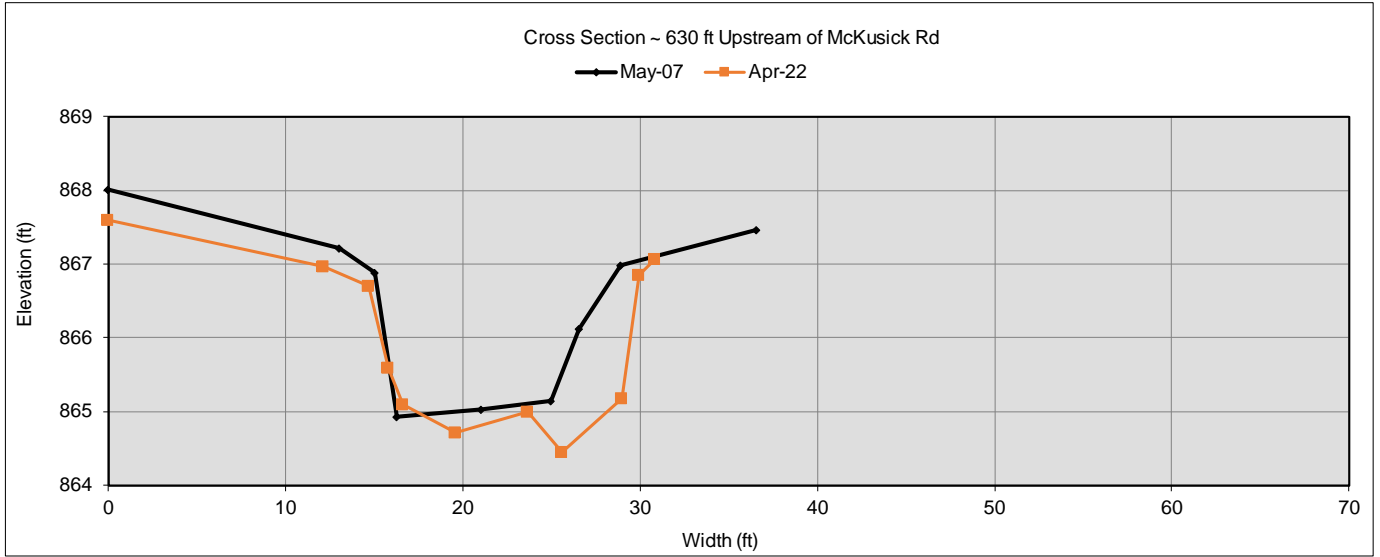
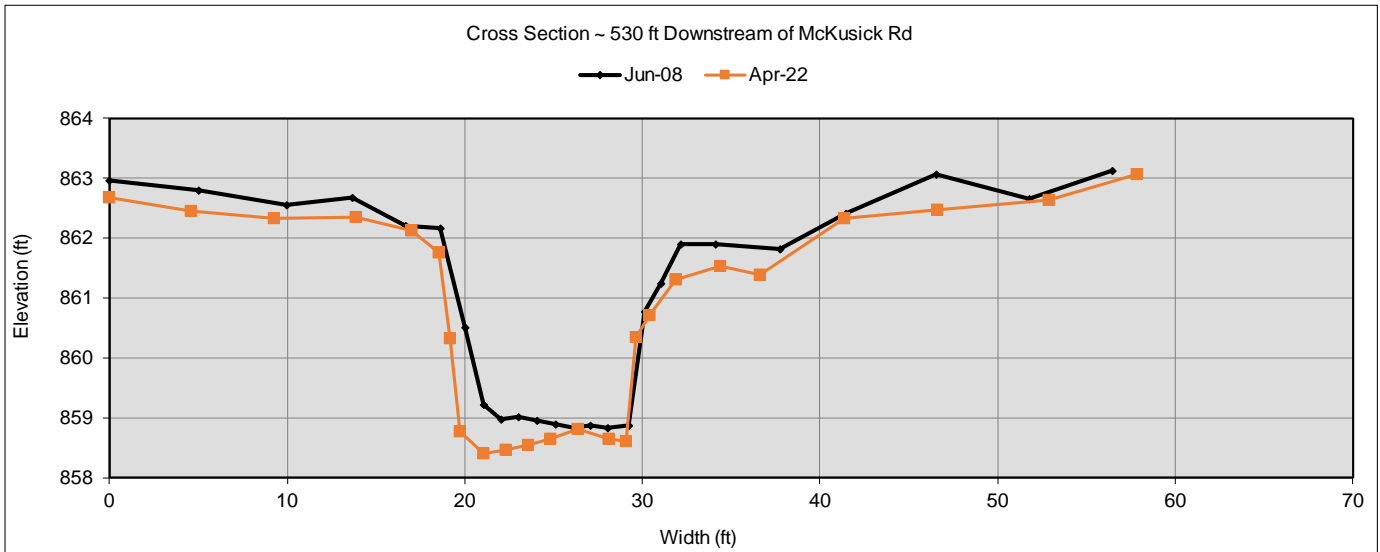
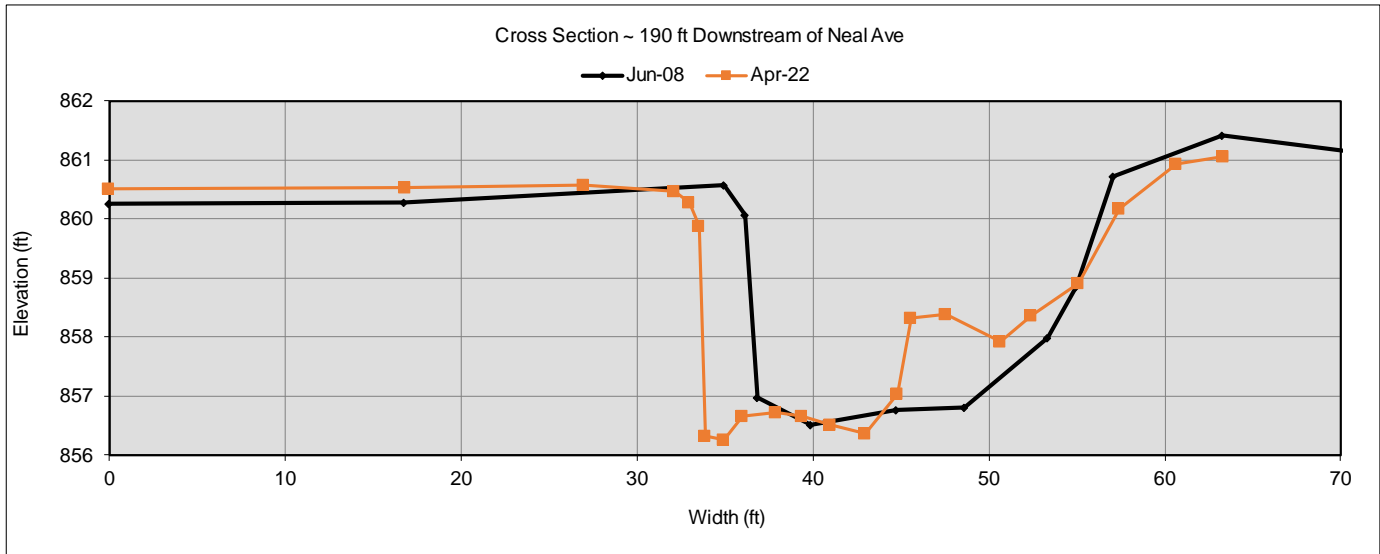
Geomorphic surveys were conducted at the same locations where baseline geomorphic surveys were completed in 2007 and 2008 and extended from Manning Avenue to the St. Croix River (see cross section plots on pages 4-8). Bank erosion rates measured at established creek cross section locations ranged from 0.1 to 0.2 feet/year, with localized bank erosion rates at a few cross sections that were near 0.5 feet/year. In the Brown's Creek gorge, bank erosion rates were very low (less than 0.1 feet/year) due to presence of bedrock and coarse substrates that protect the stream banks. Variables that affect the observed bank erosion rates include bank cover (vegetation, wood, or rock), the degree of channel incision, channel sinuosity, bank soils composition (silt/clay versus peat or sandy loam), and channel slope. Based on the cross sections surveyed between 2007/2008 and 2022, a greater amount of bank erosion has occurred between Millbrook and the Oak Glen golf course, and at a localized reach north of Oak Glen golf course compared to other reaches surveyed. Although

sediment and nutrient loading calculations from these reaches were beyond the scope of this effort, the proposed Brown's Creek Park Restoration project overlaps a significant portion of this eroded section and will reduce sediment and nutrient loads to Brown's Creek. Future stream restoration efforts should focus on the reach upstream of the western McKusick Road crossing and the reach north of Oak Glen golf course upstream of the Stone Arch Bridge.

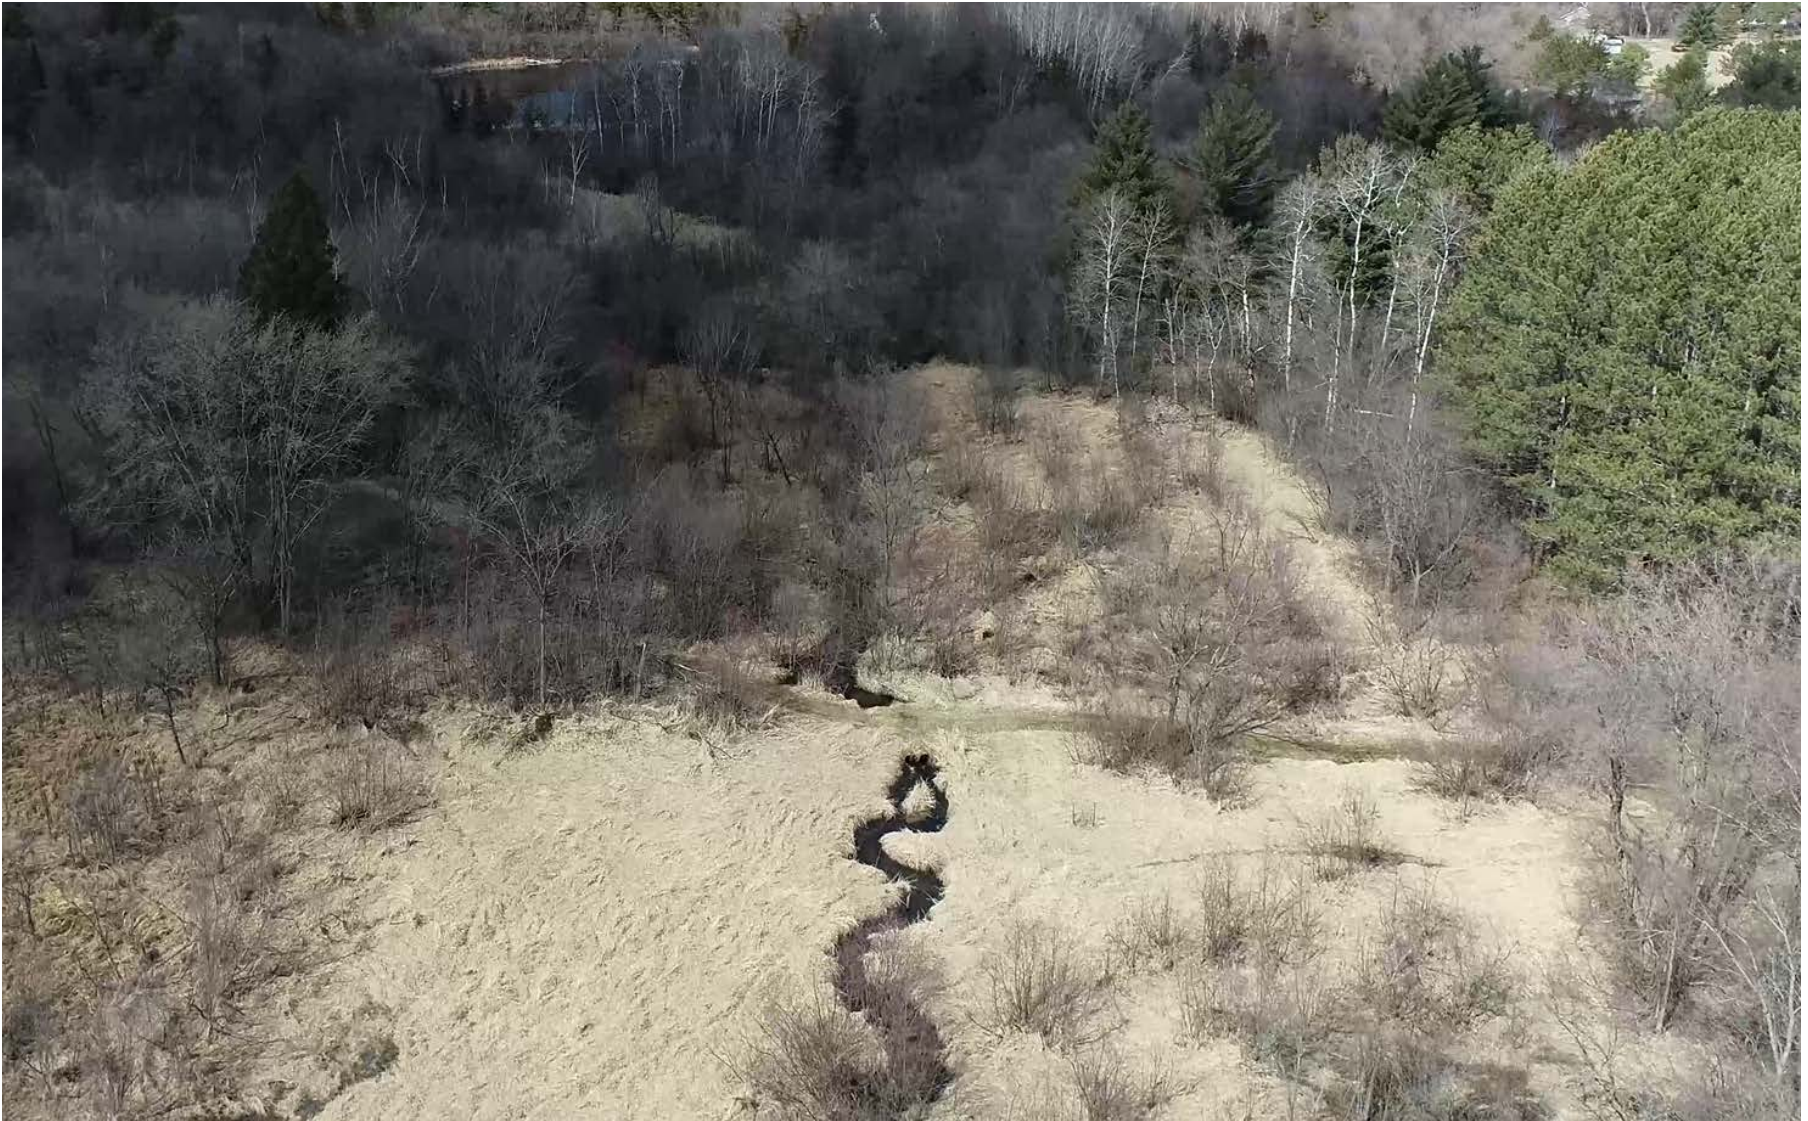
Twin culverts under a trail crossing downstream of 110th St

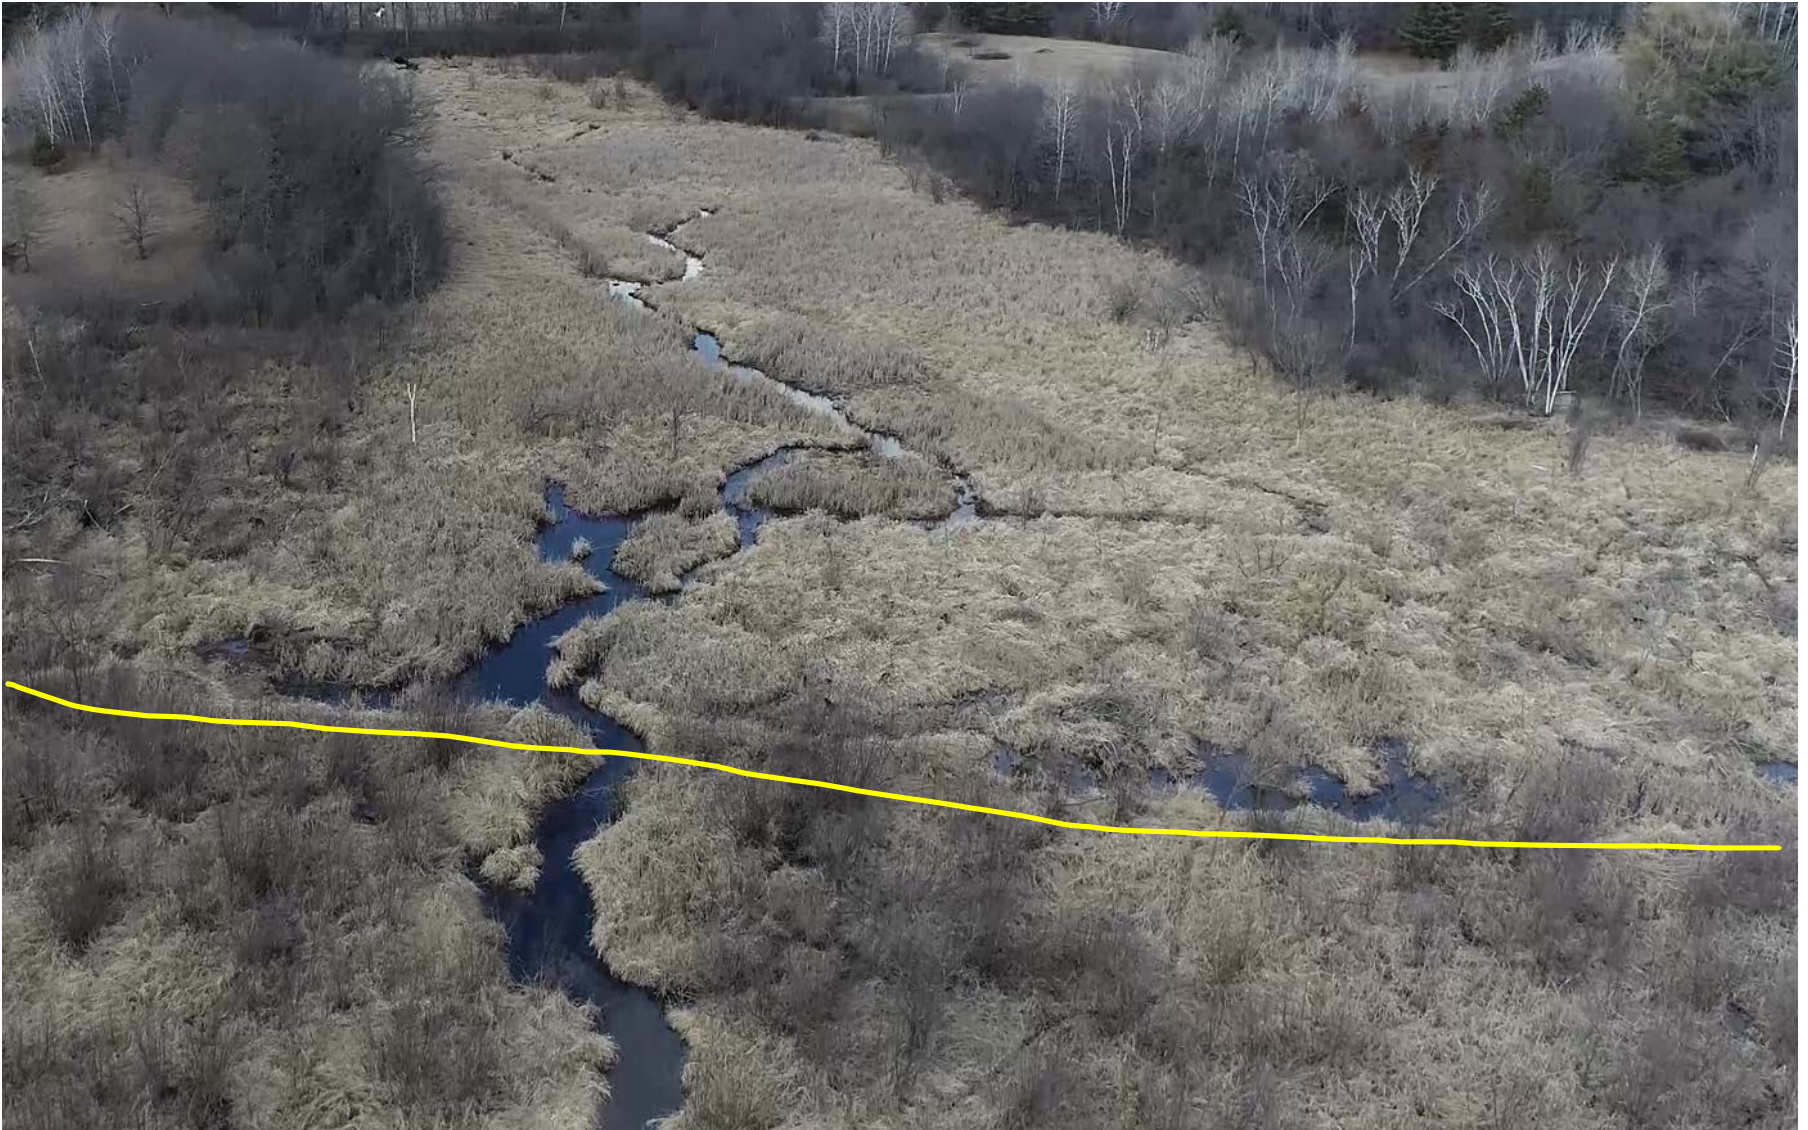
Location of previous large beaver dam (yellow line) that spanned the entire floodplain downstream of the Gateway Trail

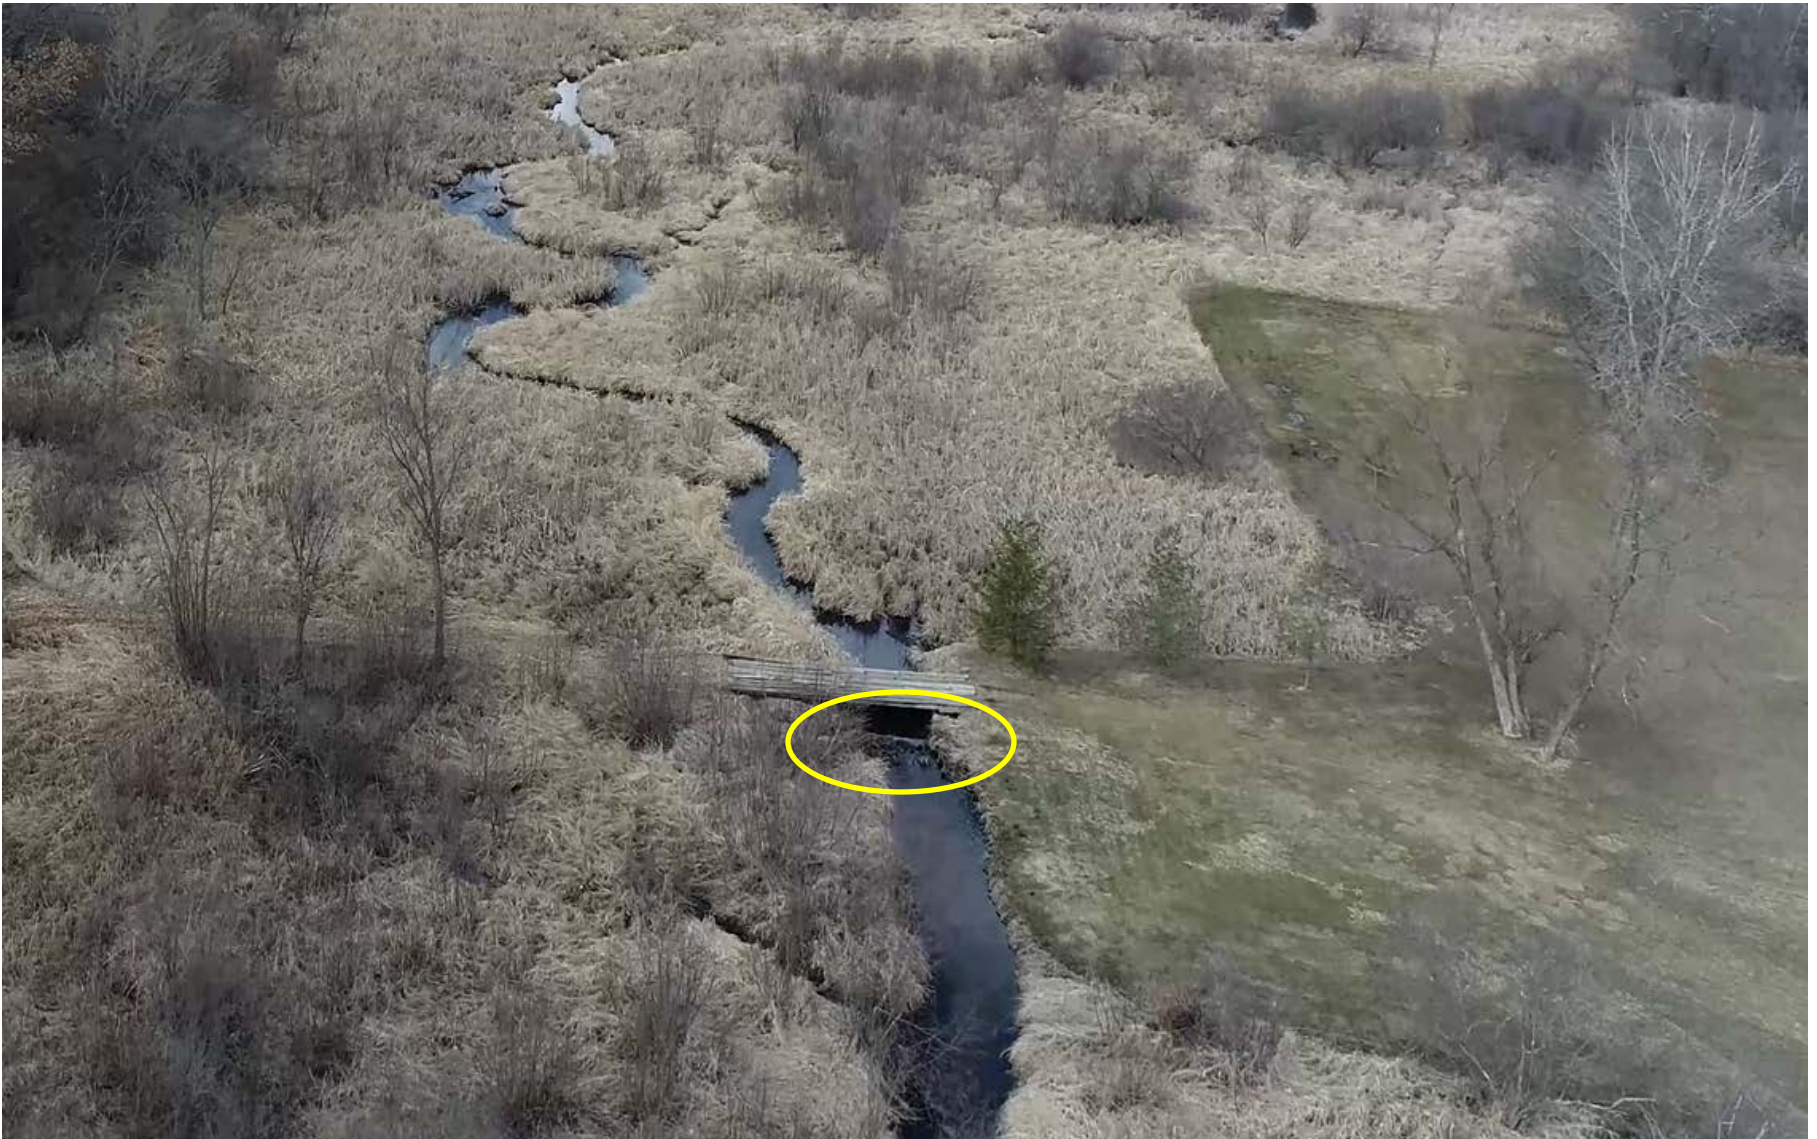
A drone flight was conducted on April 11, 2022 from Manning Avenue upstream to the headwaters north of 110th Street. Minor channel obstructions were observed from the drone including two small beaver dams at the same locations identified in 2016. No significant channel obstructions or signs of bank erosion were observed, but one new tributary crossing was identified upstream of Manning Avenue, southwest of 97th St. N. Select images taken from the drone flight are included in Appendix A, and the complete drone flight video has been archived at the BCWD office.

Wood bridge and small beaver dam (yellow oval) near private parcel west of 97th St. N / downstream of the Gateway Trail

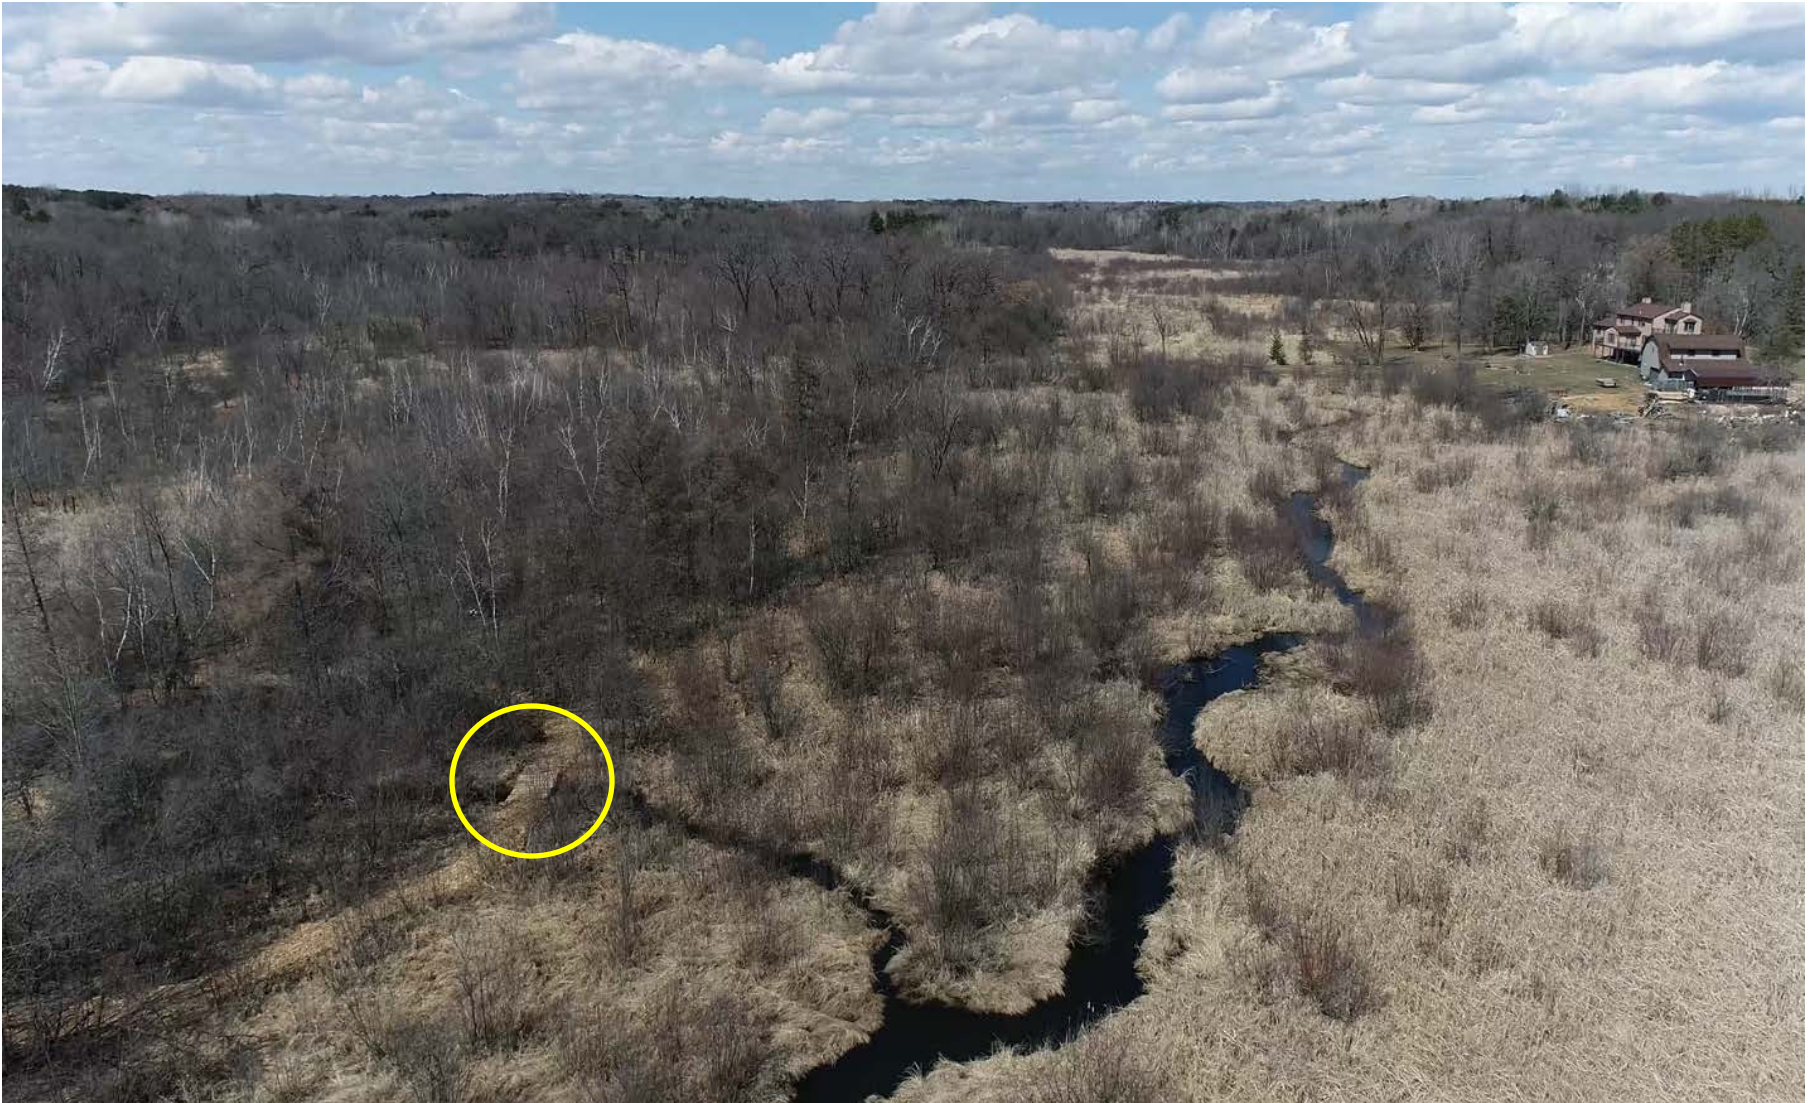
New bridge crossing (yellow circle) over a small tributary southwest of 97th Street N

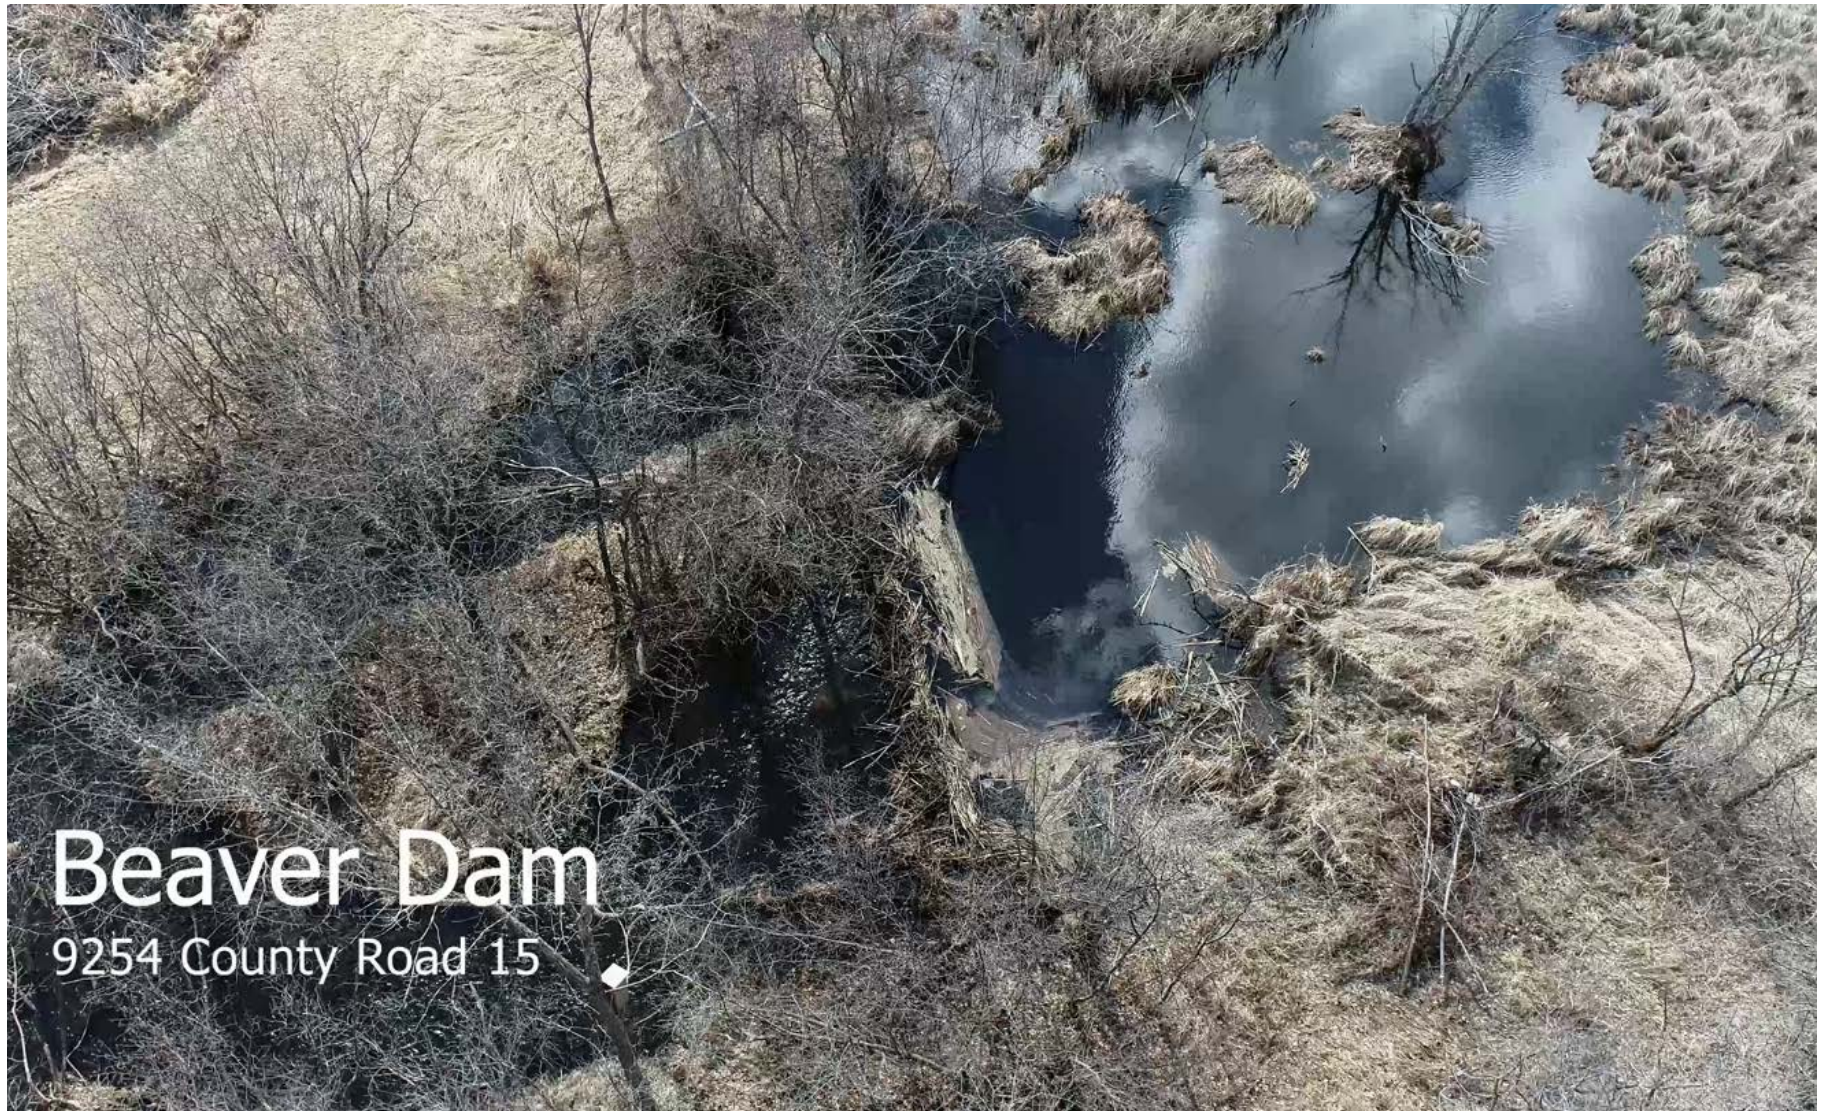
Beaver Dam

Beaver dam located upstream of Manning Avenue
