Fen Breach 1

Fen Breach Repair

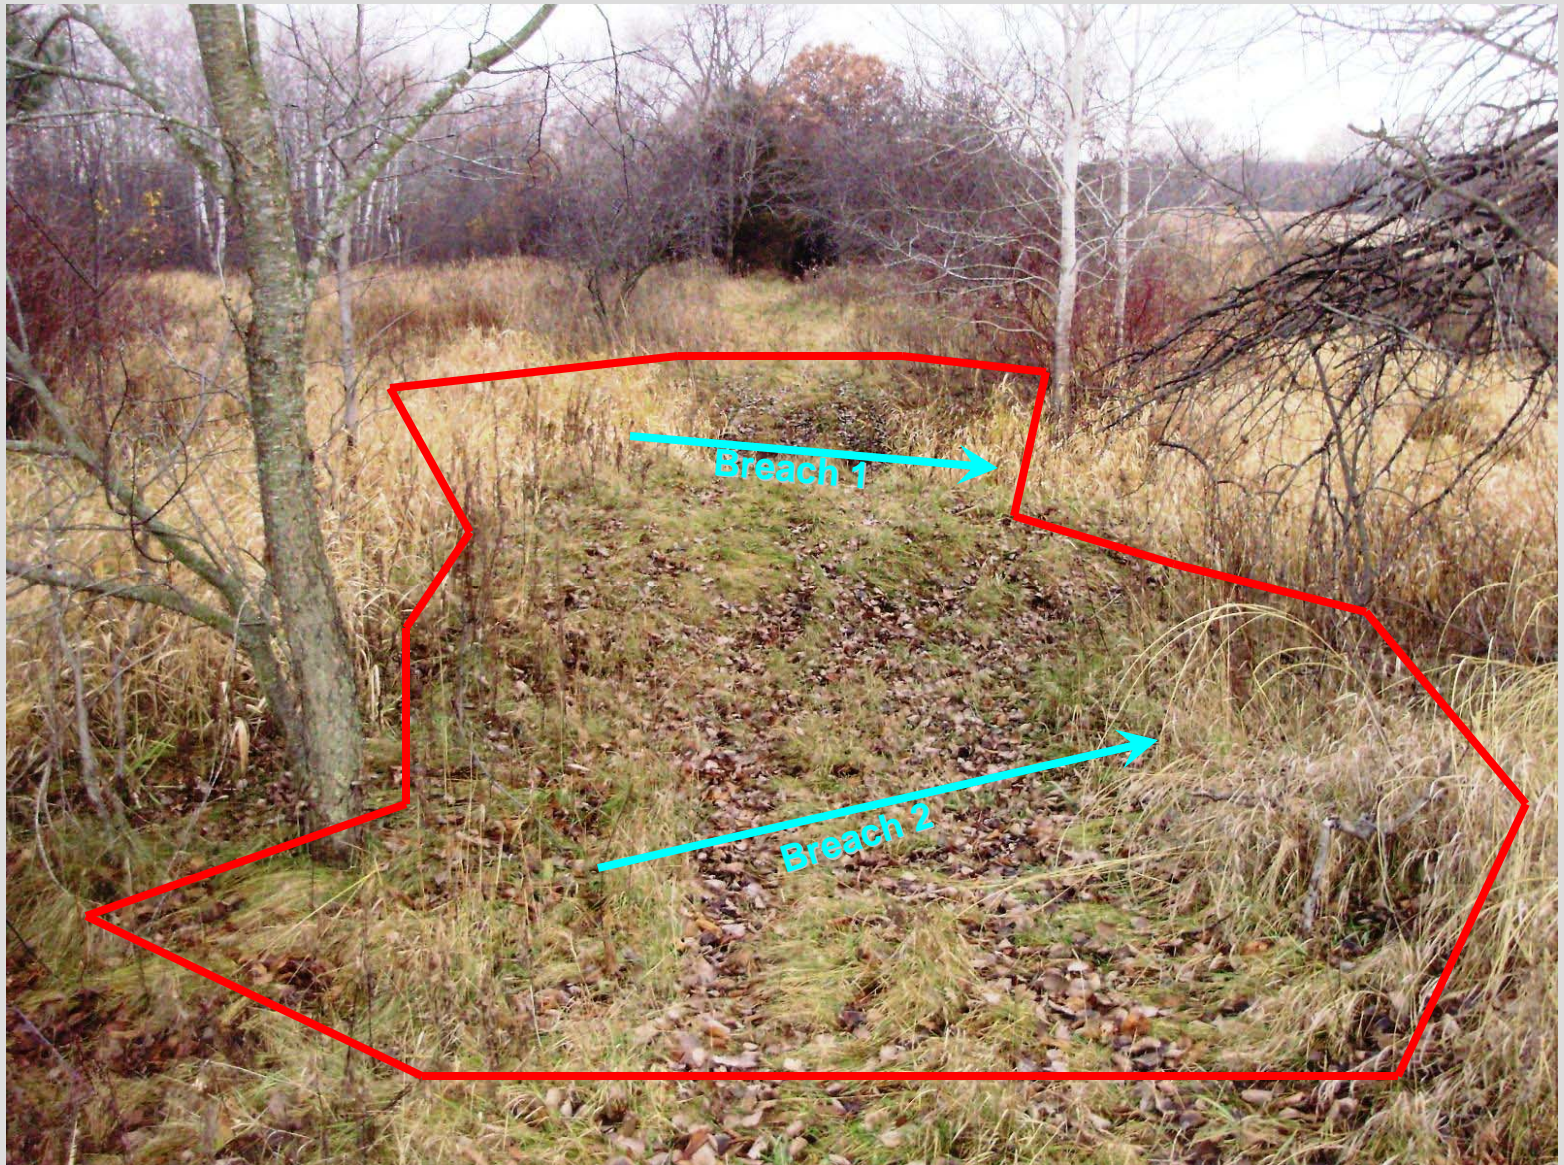
Fen Breach 1 & 2

- Flow
- Const Area

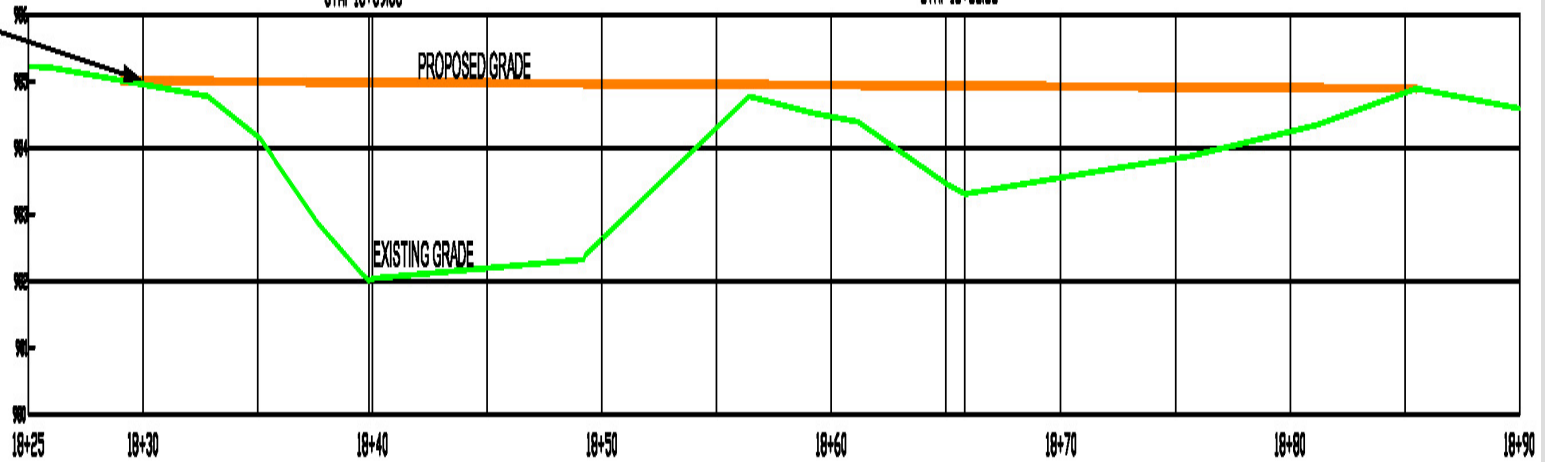
PROFILE A

CL. BREACH 1
STA. 18+39.85

CL. BREACH 2
STA. 18+65.83

FILL STREET CAR
BED BREACH 1 & 2 TO
MATCH GRADE AT
ELEVATION 985
