Project Name | Long Lake Tributary – Degradation
To | Brown's Creek Watershed District
CC | Karen Kill, District Administrator
From | Kevin Biehn
Regarding | Board Update & Recommendation

Date | Jun 30, 2015

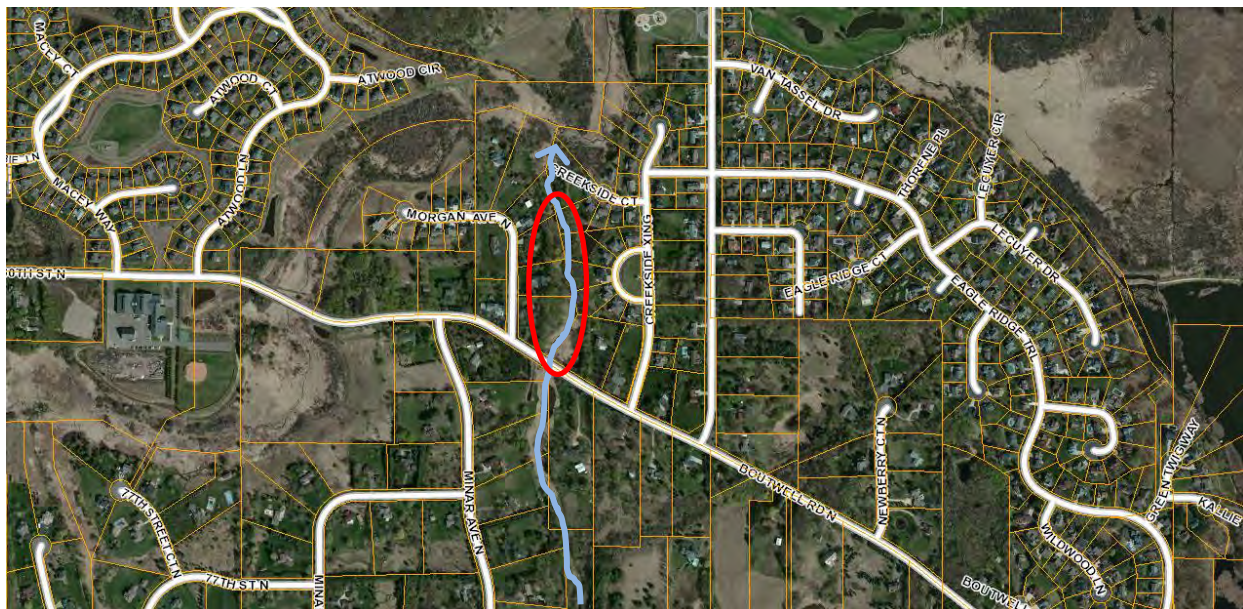
Figure 1 - Long Lake Tributary with area of focus (in red)

Among the findings of this work was the identification of stream instability on the Long Lake tributary, downstream of Boutwell Road (Figure 1). As detailed in the above mentioned draft report, the instability warranted further investigation, which was supported by the Board. This memo summarizes the findings of this further study.

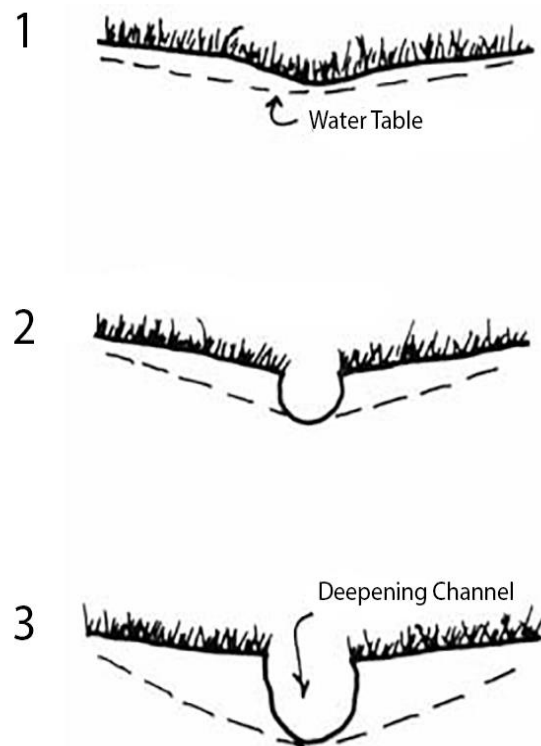
Figure 2 - Progression of Channel Incision

***Channel incision**, which is frequently associated with head cuts, is a process of channel adjustment by which the stream bed cuts into and ultimately establishes a lower bed elevation (Figure 2). The lowering bed elevation frequently separates the stream from its floodplain, which in turn results in higher channel erosivity. Channel incision is also frequently referred to as channel degradation.*

Prior to the changes in hydrology the tributary likely only carried flow during and following a period of rainfall and had less of a discernable channel [Stage 1]; The tributary has since become incised and has more perennial flow [Stage 2]; Further incision results in streambank instability and a lowering of the local water table [Stage 3].

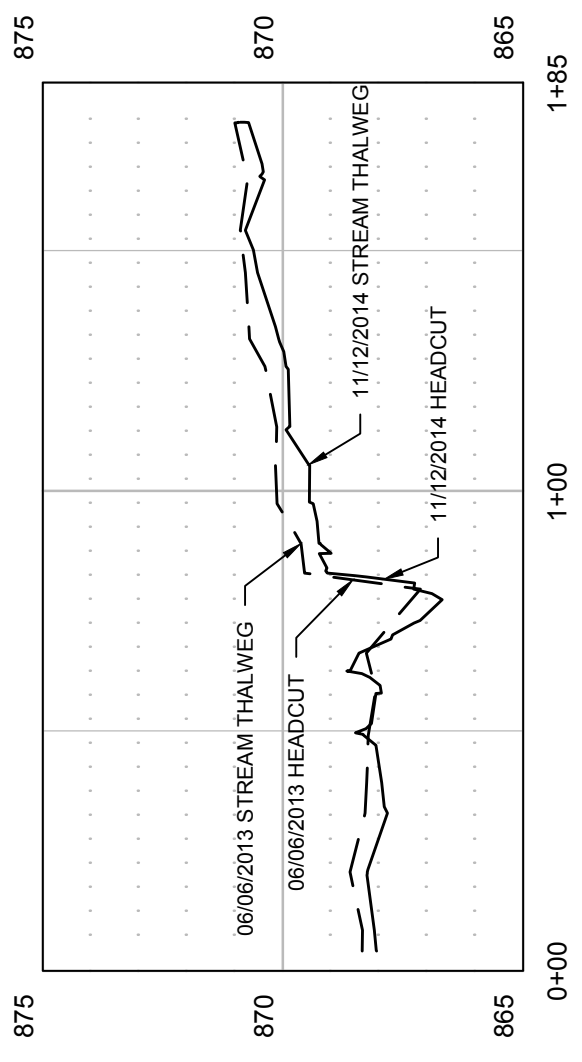
Stream Thalweg

The immediate area within the vicinity of the head cut was resurveyed as a part of this project on 11/12/2014 and compared to the 6/6/2013 survey. An estimated 22 cubic yards of soil was eroded from this area over the approximate 17 months between the survey dates (see Appendix A).

Between the two surveys dates the head cut did not substantially migrate up stream, but further channel incision was evident within the vicinity of the head cut. However, migration and further incision was apparent via recent visual observations (6/8/2015).
