Prepared by: EOR

For the Brown's Creek Watershed District

Benz Lake: Western Pasture Pond Subwatershed Study

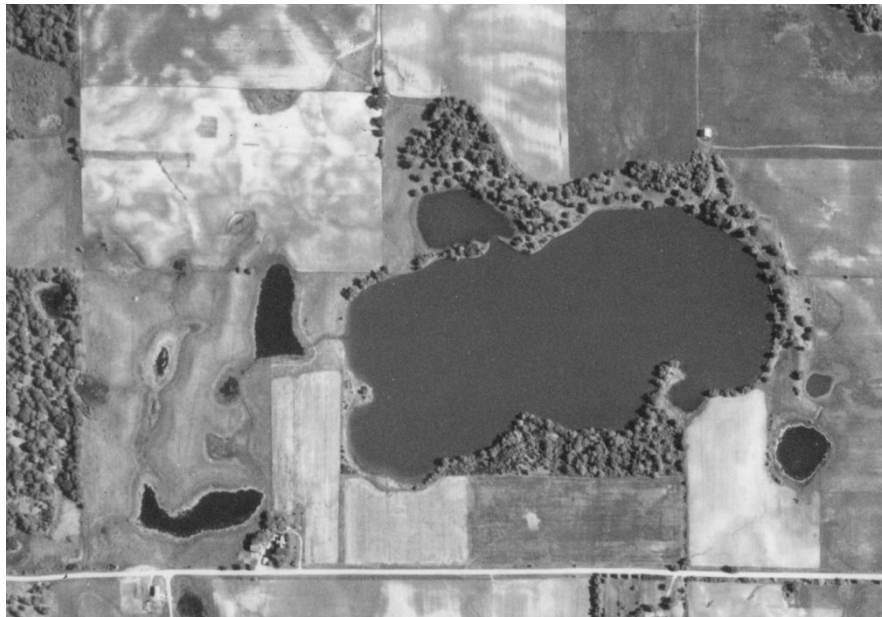
Figure 3. 1957 Aerial Photograph of Benz Lake

Most of the area west of Benz Lake flows to the southern pond (Pond 2) connects to Pond 1 via a 36" round metal culvert and into Benz Lake via a small channel (Figure 2). A review of historical aerial imagery suggests that water levels in both ponds were historically much lower than current conditions (Figure 3). Increased water levels have led to an extended hydroperiod (period of time in which soils/sediment are inundated) in areas that appear to have once been used for agriculture.

It is very likely that nutrient rich soils that were once under agricultural production are now part of the pond sediment as seen in the 1957 aerial photograph. The phosphorus load distribution to Pond 2 is approximately half from watershed runoff and half from sediment internal loading. Water quality improvements in Pond 2 will require a mix of watershed BMPs and internal load management strategies.

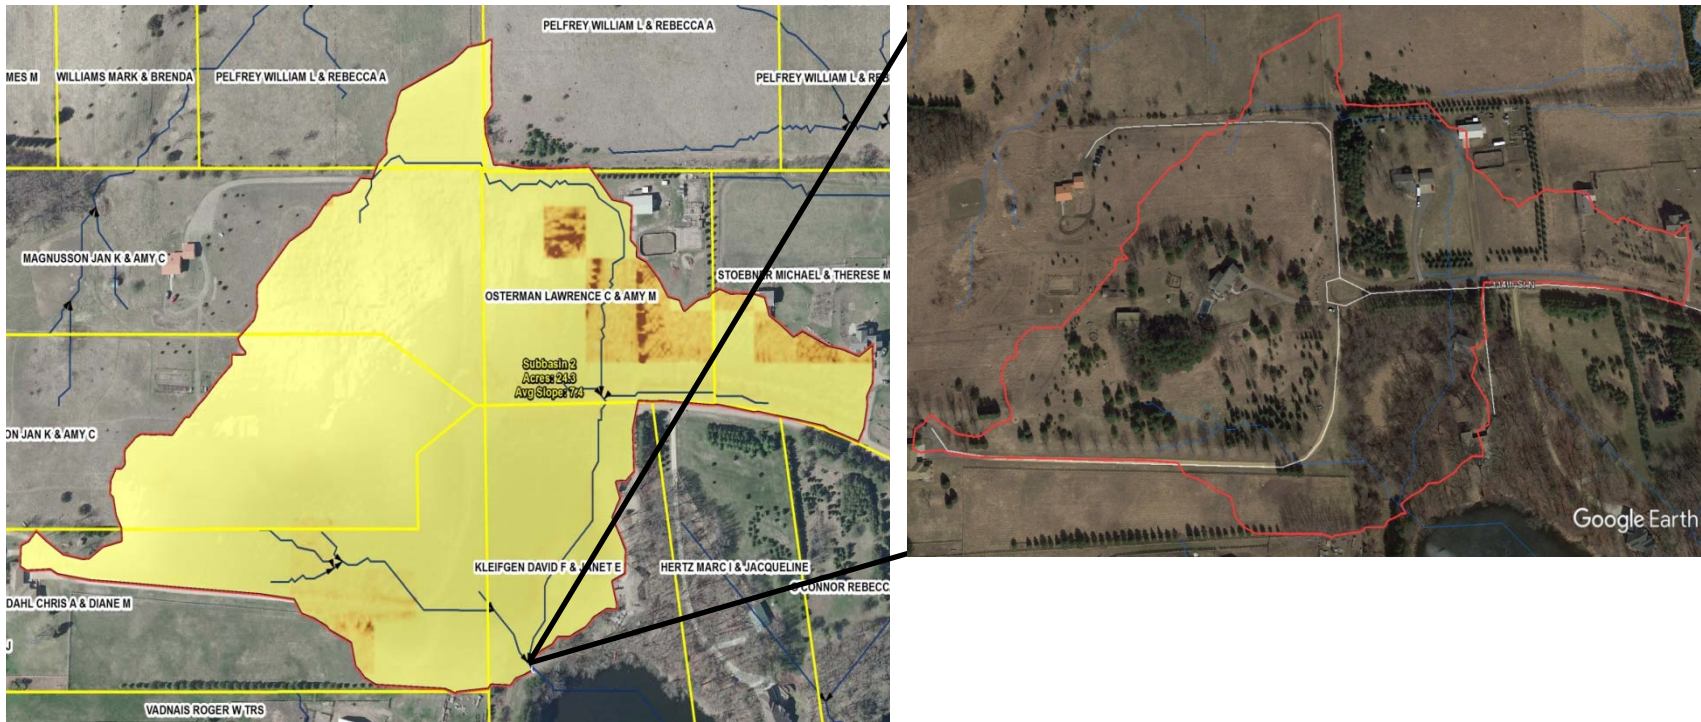
Figure 7. PTMapp Watershed BMP 2

PTMapp BMP Option 2

- Rain garden/ bioretention basin to capture runoff from two overland flow paths draining rural residential areas
- Direct to Benz Lake with no downstream wetland treatment, no erosion visible on aerial photography
- Confluence of two Stream Power Index (SPI) signatures
