# BCWD Best Management Practice (BMP)

## Monitoring Report

In 2005, the Brown's Creek Watershed District (BCWD) levied tax funds for the monitoring of Best Management Practices (BMP). This activity is identified in the BCWD Second Generation Watershed Management Plan and is intended to provide data that can be applied to future BMP design and operation and maintenance activities in the District.

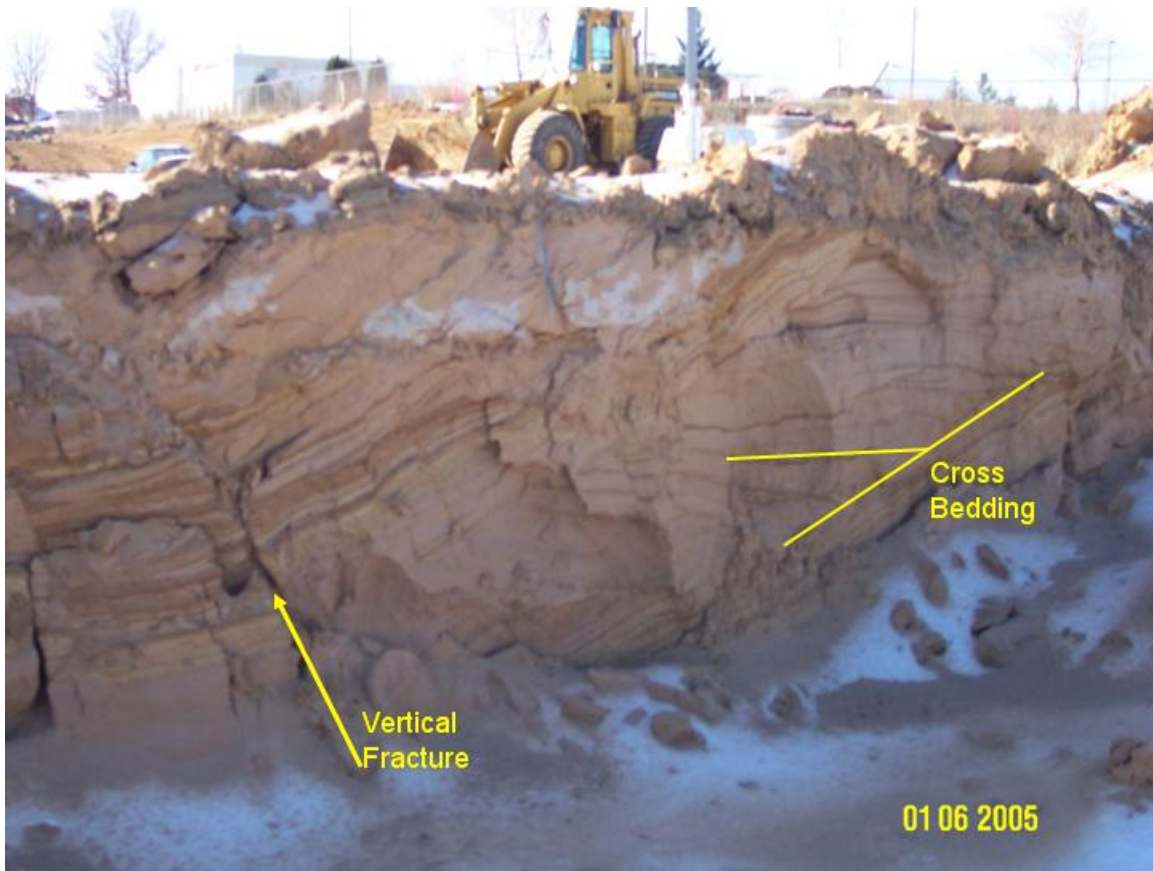
**Figure 4. Cross Bedding and Vertical Fractures at Kern Center Pond**

Soil borings were completed in 2002 to characterize site sub-surface geology as needed for the preliminary design and in 2005 to verify that trenches were unnecessary. A total of thirteen separate sites were investigated in and around the vicinity of the Kern Center Pond. Both the 2002 and 2005 borings indicate the site is dominated by fine to medium grained silty sands separated by silts and less frequently by clay. Site observations during the 2005 construction noted water moving laterally along bedding planes from west to east. High angle cross beds with fractures perpendicular to bedding planes were noted onsite (Figure 4). Such fractures provide conduits for vertical movement of water. Site geology, fine to medium grained silty sand, coupled with orthogonal bedding plane fractures makes the Kern Center site conducive for infiltration.

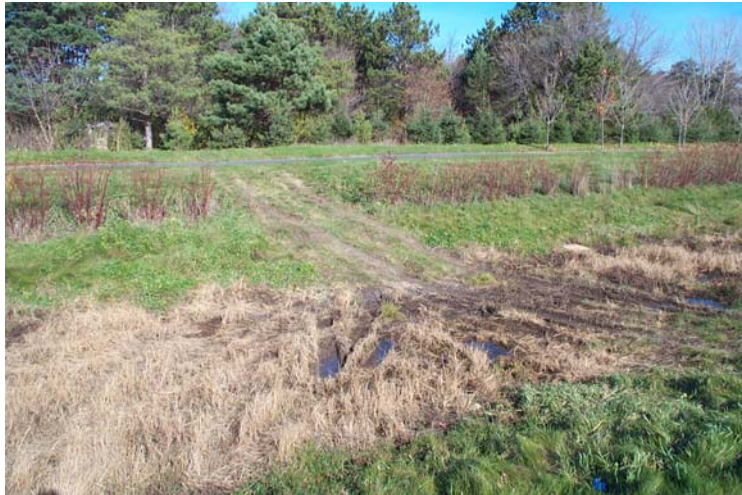
On November 7, 2005, an inspection found that people were driving through the infiltration basin. It was apparent from vehicle tracking that driving across the basin to the north was done repeatedly, possibly for access to adjacent land. Other vehicle ruts had been ripped down the length of the basin (see Figures 8 and 9). When the landowner was alerted to this activity, concerns were raised regarding snowmobile use in this area of the property during the winter.

**Figure 8. November 7, 2005 observed vehicle tracking in Bradshaw Pond**

Because this type of stormwater management practice is highly susceptible to soil clogging and compaction, potentially reducing or eliminating the capacity of the soils to infiltrate water, a letter from the District was issued to surrounding landowners requesting that there be no vehicular traffic occurring in the basin as this will potentially result in non-compliance with the District's Rules and Regulations.

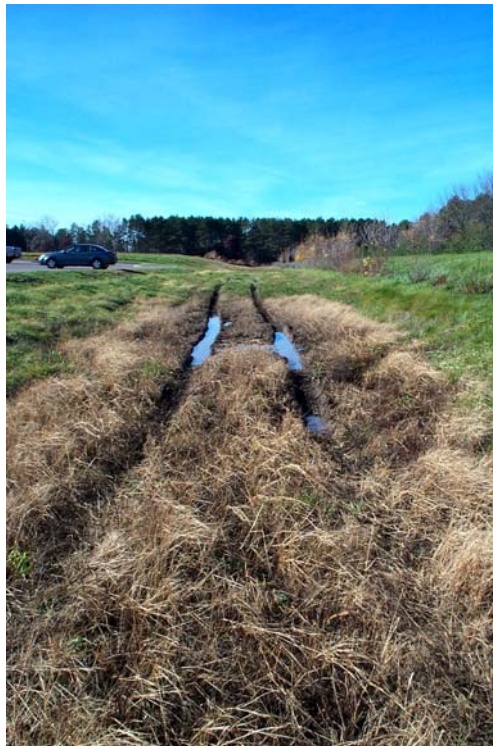
**Figure 9. November 7, 2005 observed vehicle ruts in Bradshaw Pond**
