Project Name | 2022 Aquatic Plant Management Services

Regarding | Benz Lake Point Intercept Survey

Regarding | South School Section Lake and Goggins Lake Point Intercept Survey

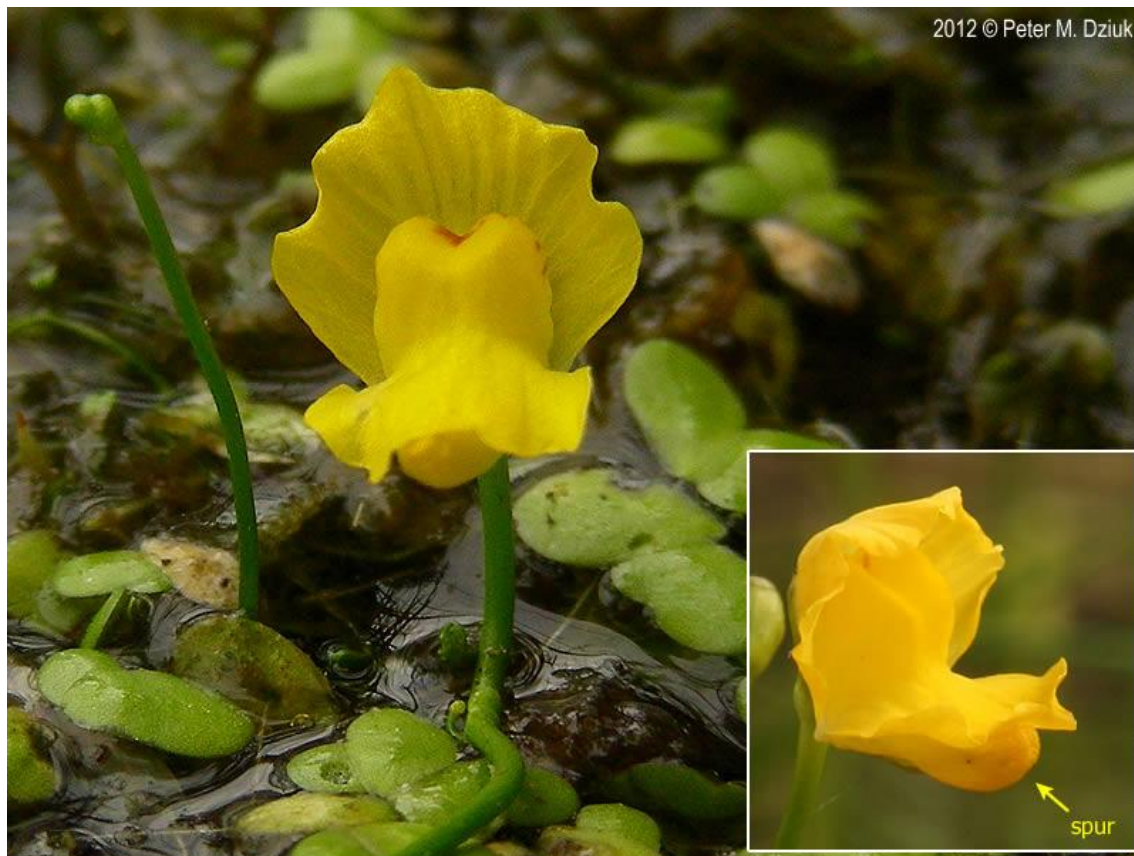
Figure 1. Creeping Bladderwort (*Utricularia gibba*) was found on Benz Lake in 2022. Photo courtesy of Minnesota Wildflowers.

than 10% frequency of occurrence. Creeping bladderwort, a notably conservative species (c-value = 9), was observed at one location (Figure 1).

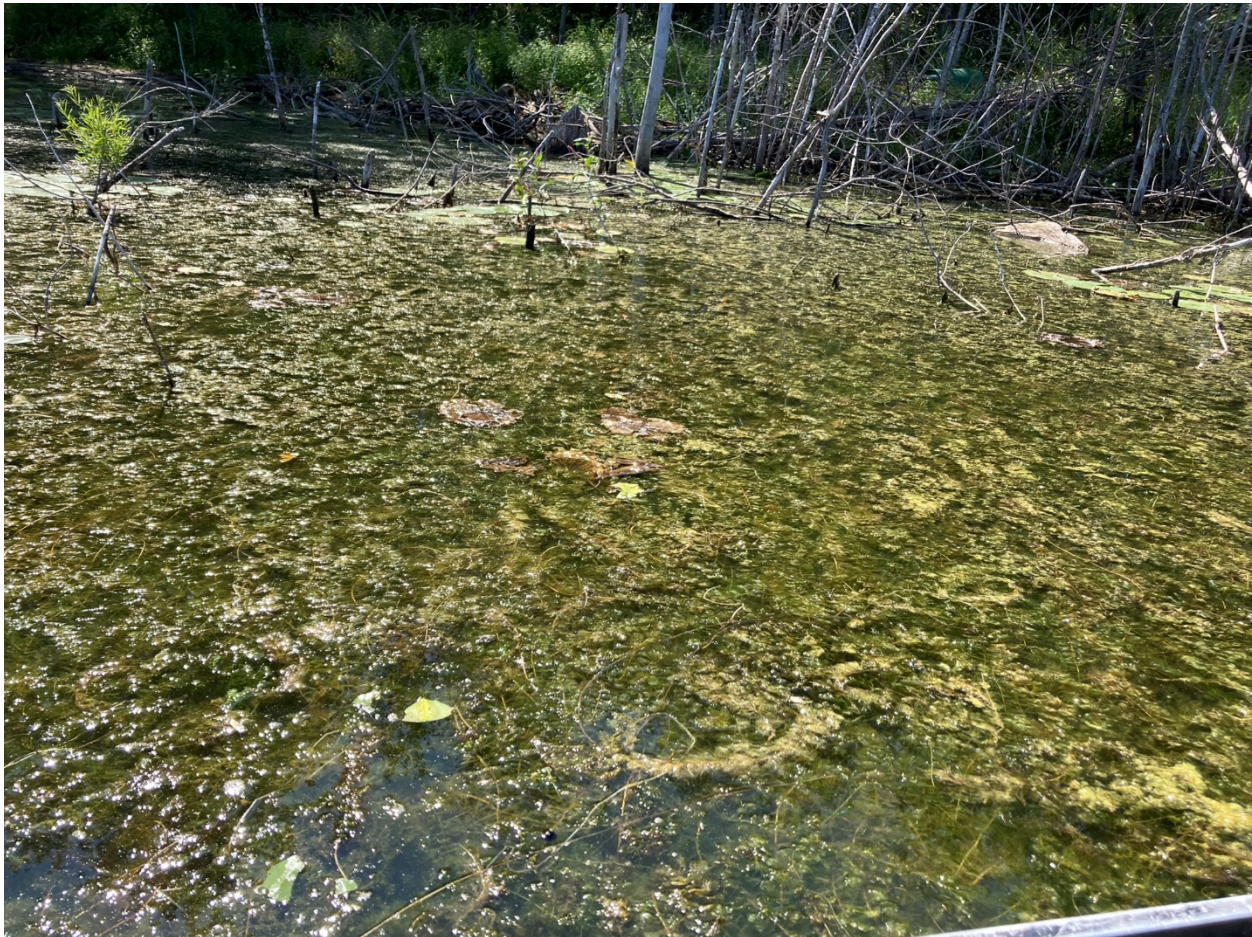
Photograph 1. Surface matting of EWM at SSSL.

Eurasian watermilfoil (EWM) was observed at 44% of the sample points in SSSL and 12.2% of sample points in Goggins Lake. Eurasian watermilfoil was generally observed growing in patches with tall prominent stalks intermixed with native species. Heavy growth was observed on SSSL in the northern portion of the lake, and it is widely distributed throughout the entire shoreline (Photograph 1). EWM density on Goggins Lake is low and more sparsely distributed throughout the lake.

EWM was documented at both SSSL and Goggins for the first time, with relatively high frequency of occurrence at SSSL (44% of sites). It is not known when EWM colonized the lakes between 2014 and 2022. High density and frequency of EWM was concentrated along the shoreline in many areas that were likely above the lake elevation in 2014. Higher water levels may have facilitated EWM colonization before native plants (or CLP) could establish in newly inundated areas. Unlike CLP, EWM competes directly with native vegetation and aggressive growth forms mats that shade out competitors (Photograph 1). Continued expansion of EWM could negatively impact FQI scores in the future.

Further, given that the quality of the aquatic plant community appears to be at least stable and possibly increasing, EOR is not recommending treatments to target EWM. However, the increase in the abundance of EWM should be monitored via early summer point-intercept aquatic plant surveys conducted every three years (e.g., 2025). If the frequency of EWM continues to increase to the detriment of the native plant community, EOR would likely recommend that BCWD explore herbicide treatments using ProcellaCOR. EOR has had outstanding success with ProcellaCOR treatments on lakes in Wisconsin and Minnesota both in terms of control of the target species (EWM) and avoidance of impacts to the native plant community. Progress towards achieving control of these target species is subject to change based on feedback from lake users and methods of control.
