Iron Enhanced Sand Filter Performance and O&M

Emily Johnson, EOR

BCWD Iron Enhanced Sand Filter Performance and O&M

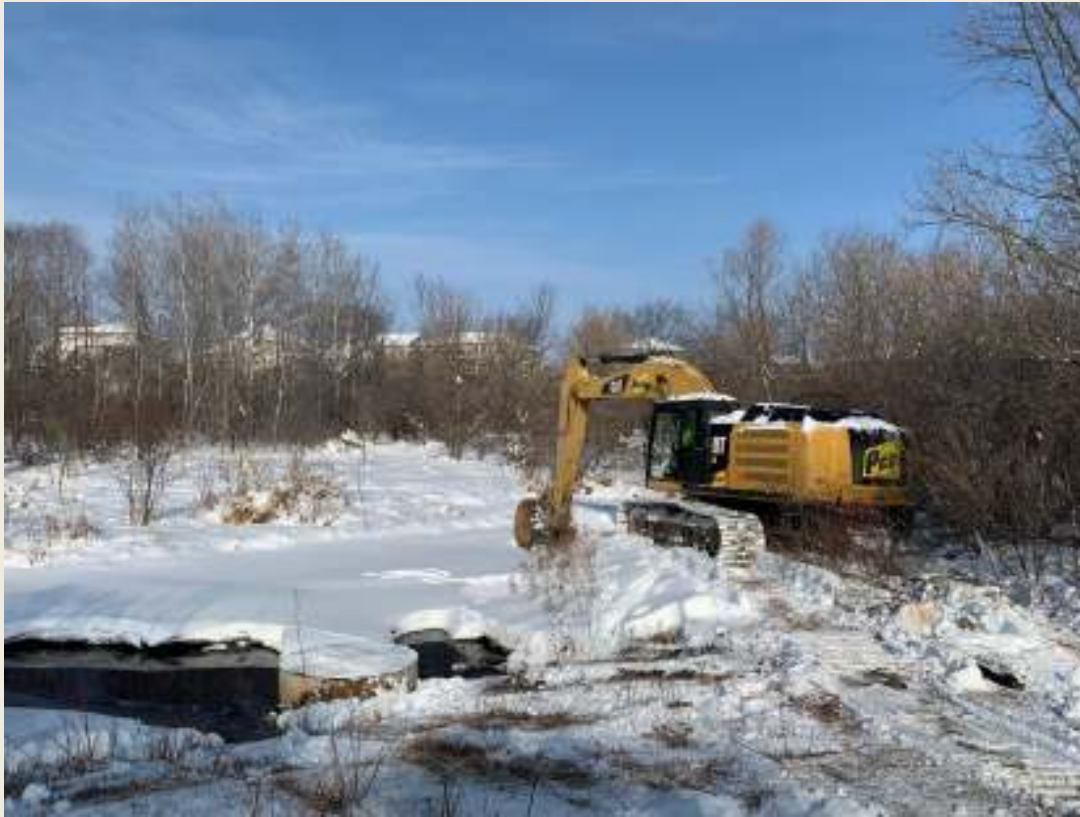
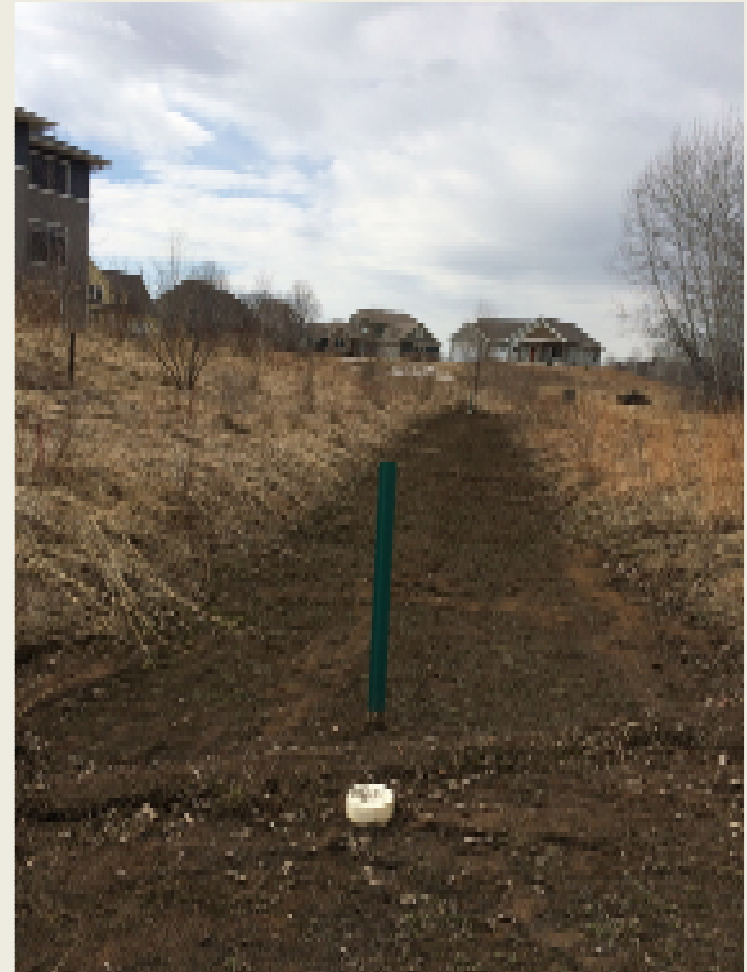
Above: Winter pump harvest pond sediment removal
Right: IESF surface aeration

Filter Surface Aeration

- Breaking up the filter surface to encourage flow into filter
- Completed April 2019

Accumulated Sediment Removal (Pump Harvest Pond)

- Winter of 2018/19, removed approximately 200 cubic yards of material
- Sediment has accumulated in 5 years of operation
- Restore capacity of pump harvest pond
