Project Name | Mendel Road Wetland

Regarding | DRAFT MEMO - Floristic Inventory & Site Survey Findings

MENDEL ROAD WETLAND
BROWNS CREEK WATERSHED
DISTRICT, WASHINGTON COUNTY,
MINNESOTA

PLAN OVERVIEW

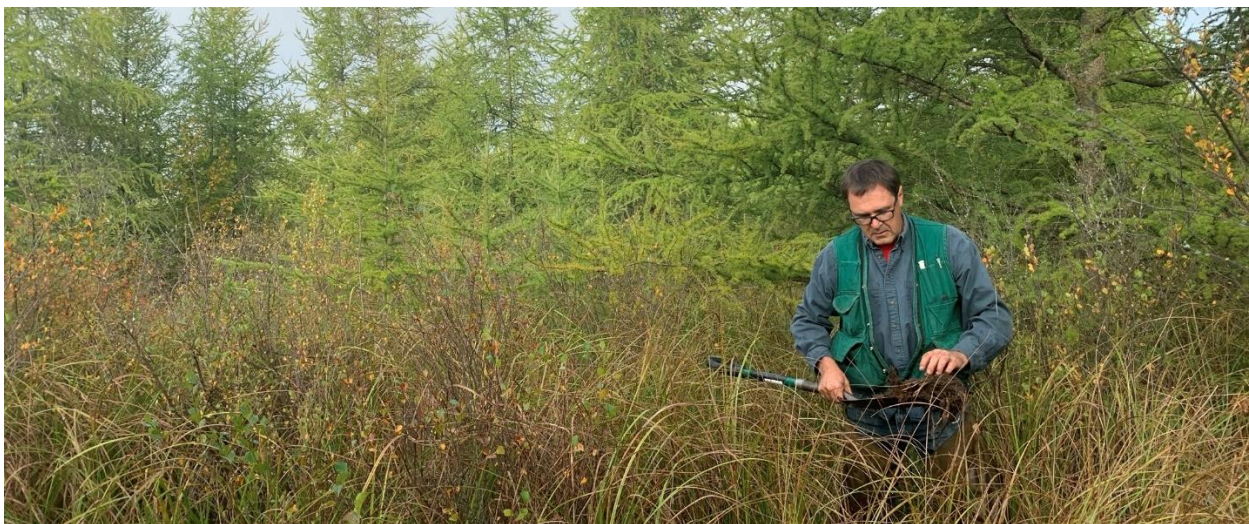
Figure 2 – 9/25/2020 photograph of an area (near Soil Test Pit #205) of the wetland with higher floristic quality

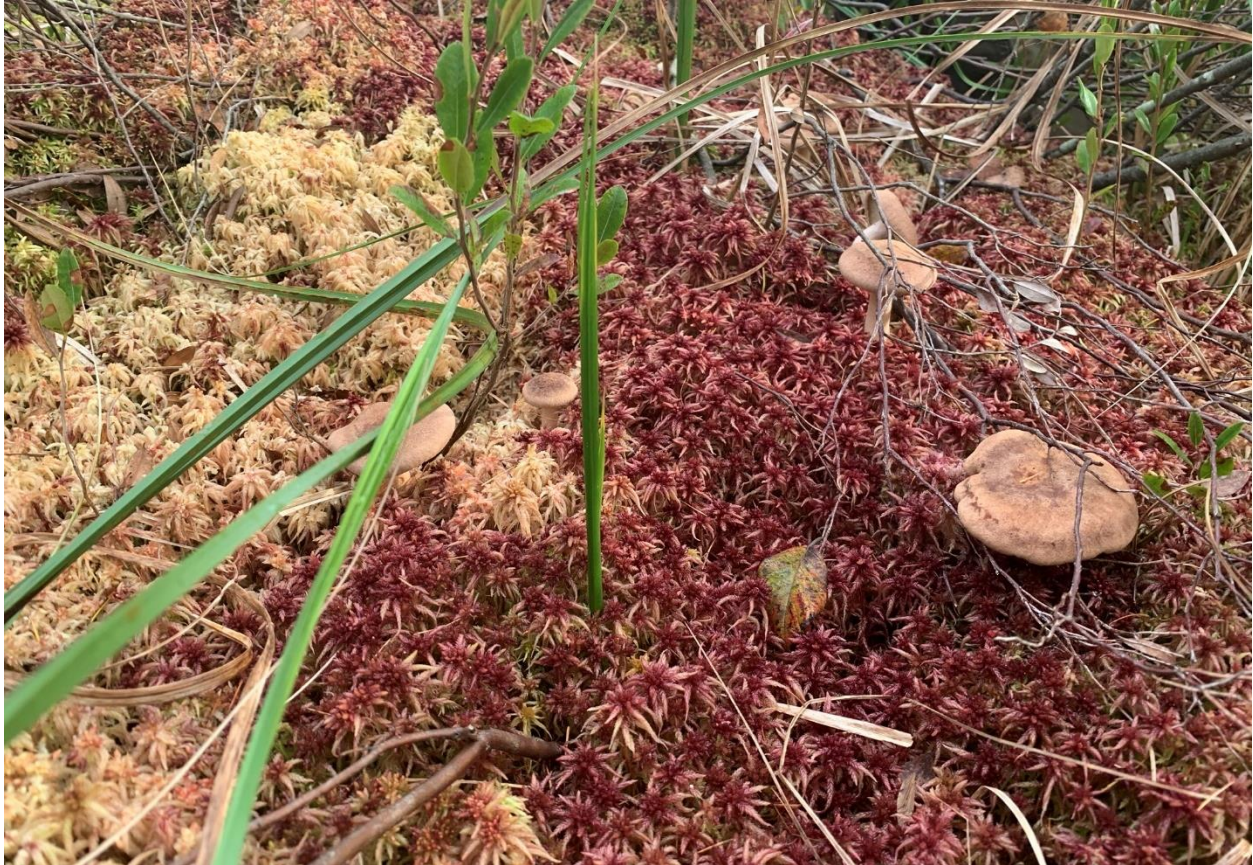
Figure 5 - 9/25/2020 photograph of an area (near Soil Test Pit #205) with a rich *Sphagnum* moss composition

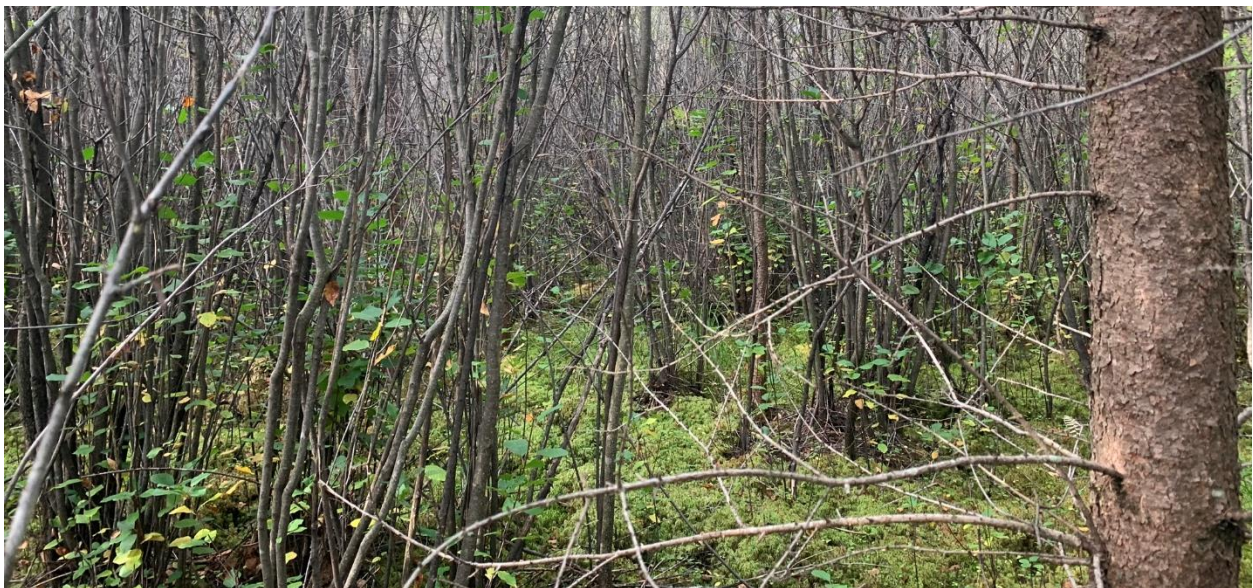
Figure 6 - Representative 9/25/2020 photograph of colonization by Glossy buckthorn (*Frangula alnus*), an invasive species that dominates the wetland

Coniferous Bog of poor and fair quality were identified within FQA plots. The quality was mostly dependent on dominance or presence of the invasive shrub glossy buckthorn. Vast areas are severely invaded and almost entirely glossy buckthorn with a few remnant bog and wet-meadow species, but no tamarack. Such areas are mapped as Bog/Shrub-Carr (Glossy Buckthorn-Invaded). Despite the presence of glossy buckthorn, many areas dominated by tamarack and other bog species remain. Condition scores appear low, since they are relative to statewide quality of Coniferous Bogs. However, FQI indices such as weighted Coefficient of Conservatism (wC) are quite high relative to good and excellent Fresh Meadow communities of the Mendel Road wetland. In general, even a poor-quality Coniferous Bog harbors unique and often rare species which are sensitive to disturbance and uncommon in the metro area. If glossy buckthorn was removed from the fair quality FQA plots, they would meet or approach standard for good quality Coniferous Bog.
