<b>Project Name</b>	Brown's Creek Tributaries Restoration Project	<b>Date</b>	12/4/2024
<b>To / Contact info</b>	BCWD Board of Managers		
<b>Cc / Contact info</b>	Karen Kill, District Administrator		
<b>From / Contact info</b>	Mike Majeski, Dan Mousing, P.E.		
<b>Regarding</b>	Benefits of Recent Beaver Activity & Dams

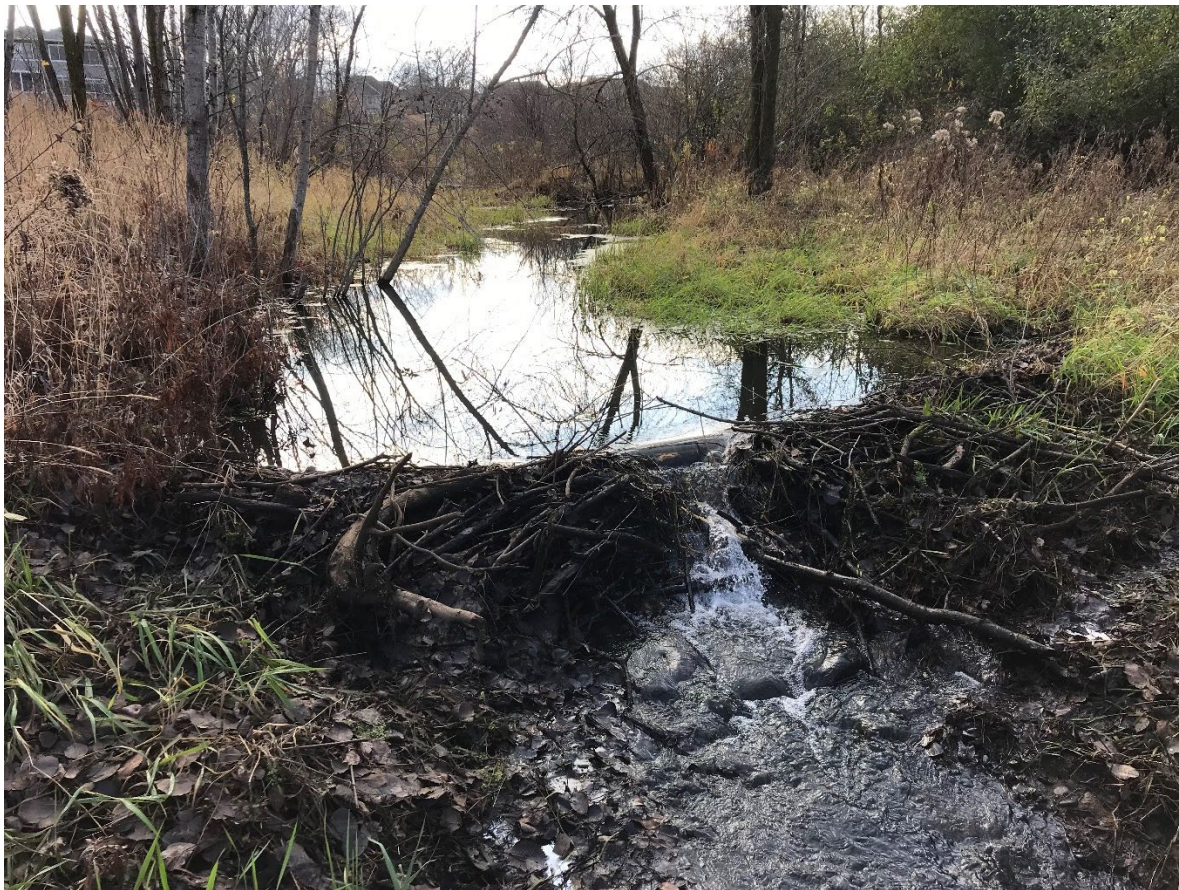
Several beaver dams were documented in 2024 including one located just upstream of the Diversion Structure, three smaller dams upstream of the wooden walk bridge north of the IESF filter (Figure 1), and a very large dam at the north end of the IESF pump pond (Figure 2).

Figure 1. One of three small beaver dams upstream of the wood walk bridge north of the IESF filter.

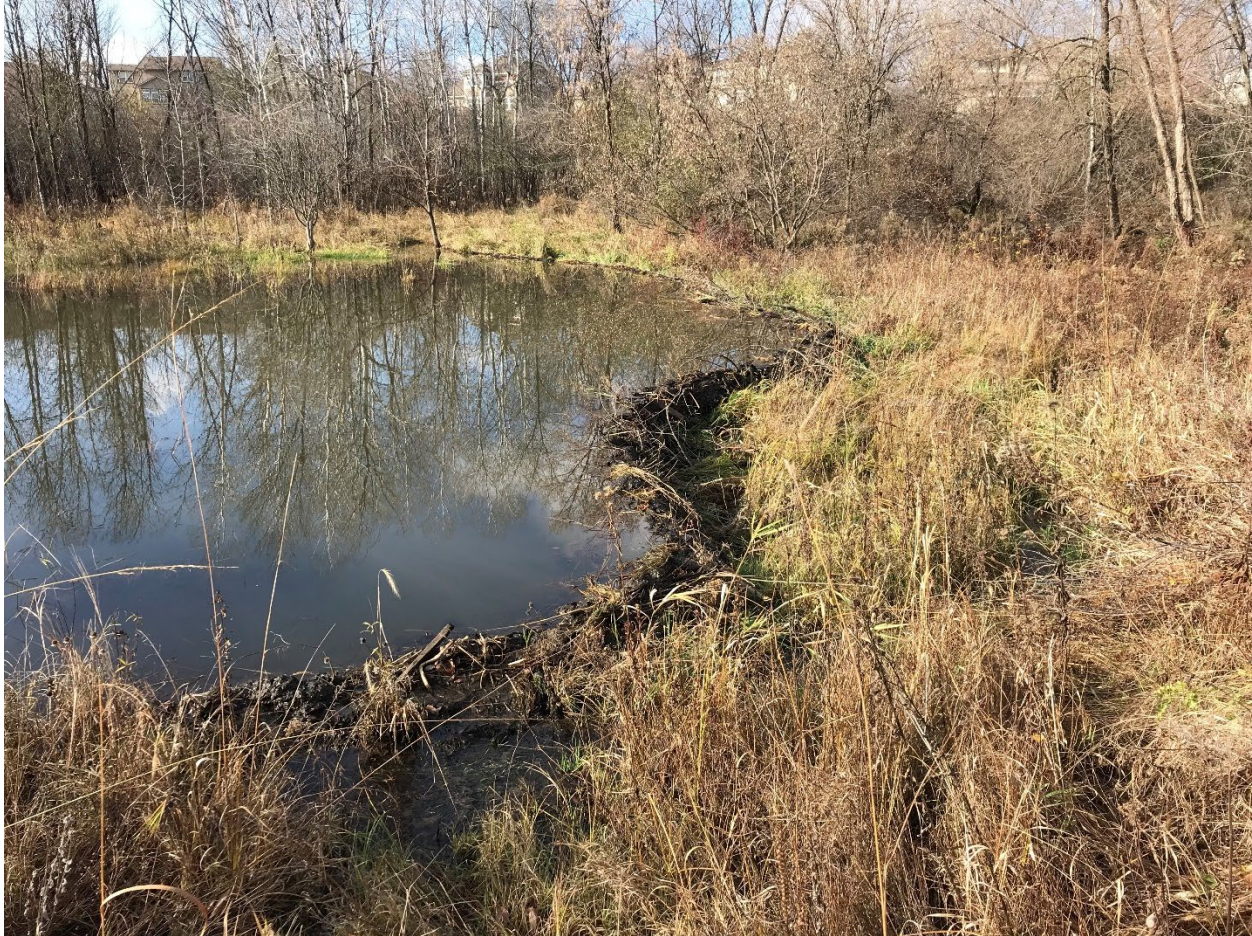
Figure 2. Large beaver dam at the north end of the IESF pump pond.

The Tributaries Restoration Project was developed to address channel incision (downcutting of the stream bed), floodplain abandonment, and degraded native vegetation along the three tributaries upstream of the Diversion Structure. Two primary goals of the project included reconnecting the tributaries to their floodplains and restoring wetland hydrology to support wetland plant communities. These goals were largely achieved following installation of the rock riffles that prevented further channel incision and increased baseflow water elevations in the channel which restored hydrology of the adjacent wetlands. The addition of beaver activity in the project site has further benefited the resource by impounding water on the floodplains which intercept suspended sediment and absorb nutrients that would otherwise discharge to Lake McKusick. The beavers are also helping to restore the native sedge/ shrub community that existed here prior to development by foraging on pioneer and early successional trees such as aspen and boxelder that have invaded the wetlands following degradation of the riparian corridor (Figure 3). Due to the stacked benefits the beavers provide, it is recommended the beavers be left undisturbed to promote natural restoration of the riparian corridor. However, if the large beaver dam at the IESF pump pond continues to increase in elevation, a water level management system such as a “beaver pond leveler” (Figure 4) should be considered to allow the IESF facility to function as designed.

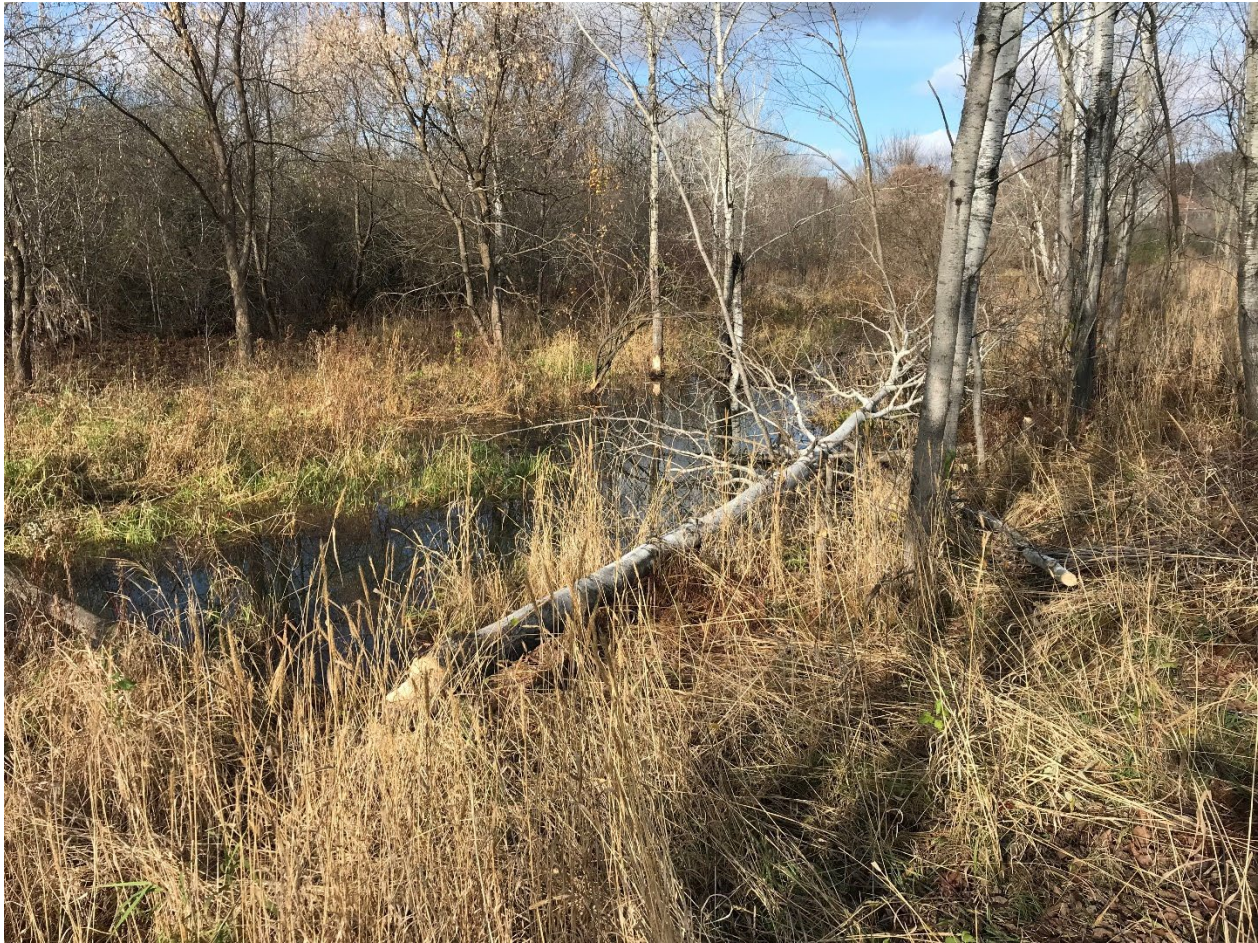
Figure 3. Example of beaver foraging on aspen and other early successional trees along the tributary corridor.
