Prepared by:  
Emmons & Olivier Resources, Inc.  
for the Brown's Creek Watershed District

## Masterman Lake Management Plan

November 2010

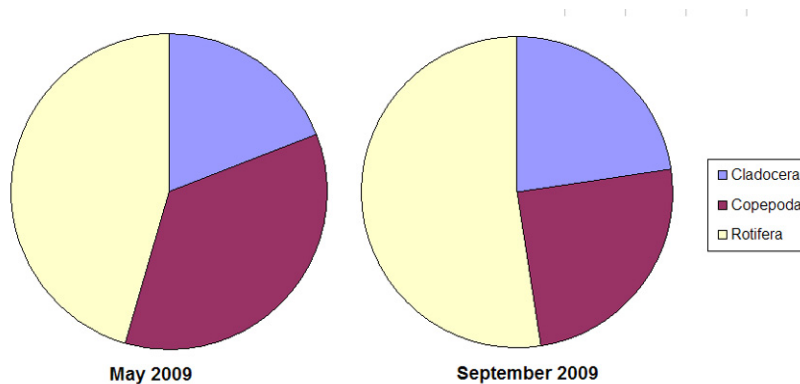
Figure 4. Zooplankton community.

Figure 4 is a simple way to show community dominance and its seasonal change. Rotifer (smaller organism) dominance shown usually indicates a decent amount of planktivory by pan fish on the larger crustacean groups. Lack of normal littoral vegetation can produce this effect, removing refugia from predation; the effect can also be due to over-stocking pan fish. Excess planktivory by fish can suppress the 'grazing potential' of the plankton community, suppressing trophic controls on algal blooms. The crustacean copepod population decreases from May to September. Conversely, populations of rotifera and the crustaceans of the order Cladocera increase from May to September. However, the population change is slight. Overall, Masterman Lake exhibits a balanced community of zooplankton, which implies a balance, in turn, with the community of pan fish.

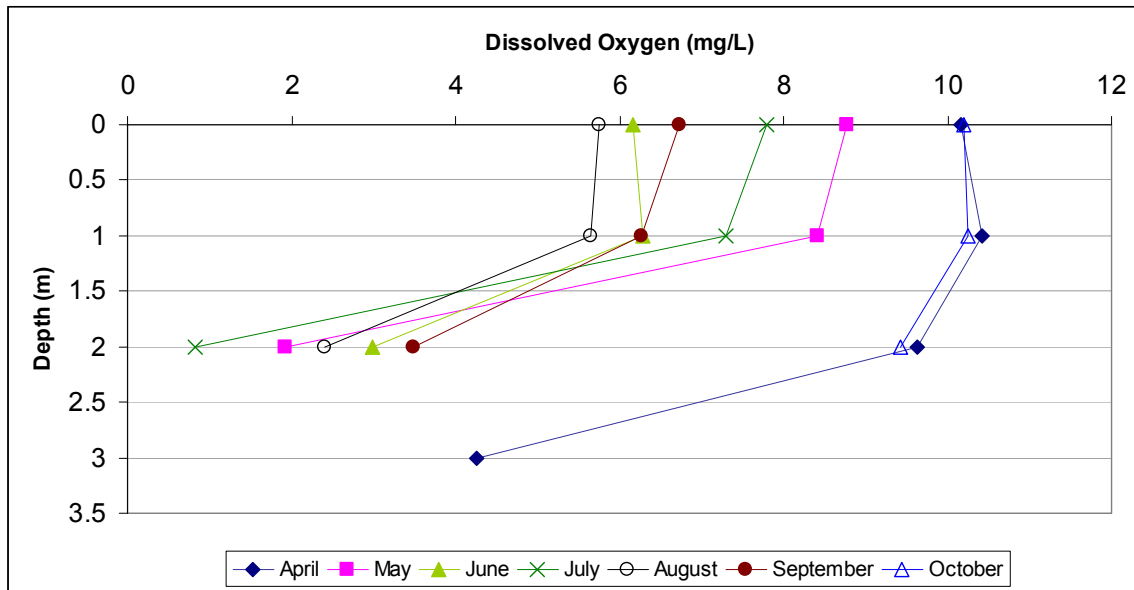
Figure 7. 2009 average monthly dissolved oxygen profiles.

Masterman Lake temperature and dissolved oxygen profiles for 2009 are shown in Figure 6 and Figure 7. Temperature and dissolved oxygen data were recorded from 2006 to 2009. However, only 2009 data is presented here. Data indicate the lake did not permanently stratify (thermally) in 2009. This is typical for shallow lakes. Dissolved oxygen decreases with depth. When the dissolved oxygen gets below around 2 mg/L in the bottom then phosphorus will be released from sediments. It could be that oxygen gets low in the bottom part of the lake, but data are inconclusive since the lowest probe can often be a reading of dissolved oxygen in the sediment rather than the water column.

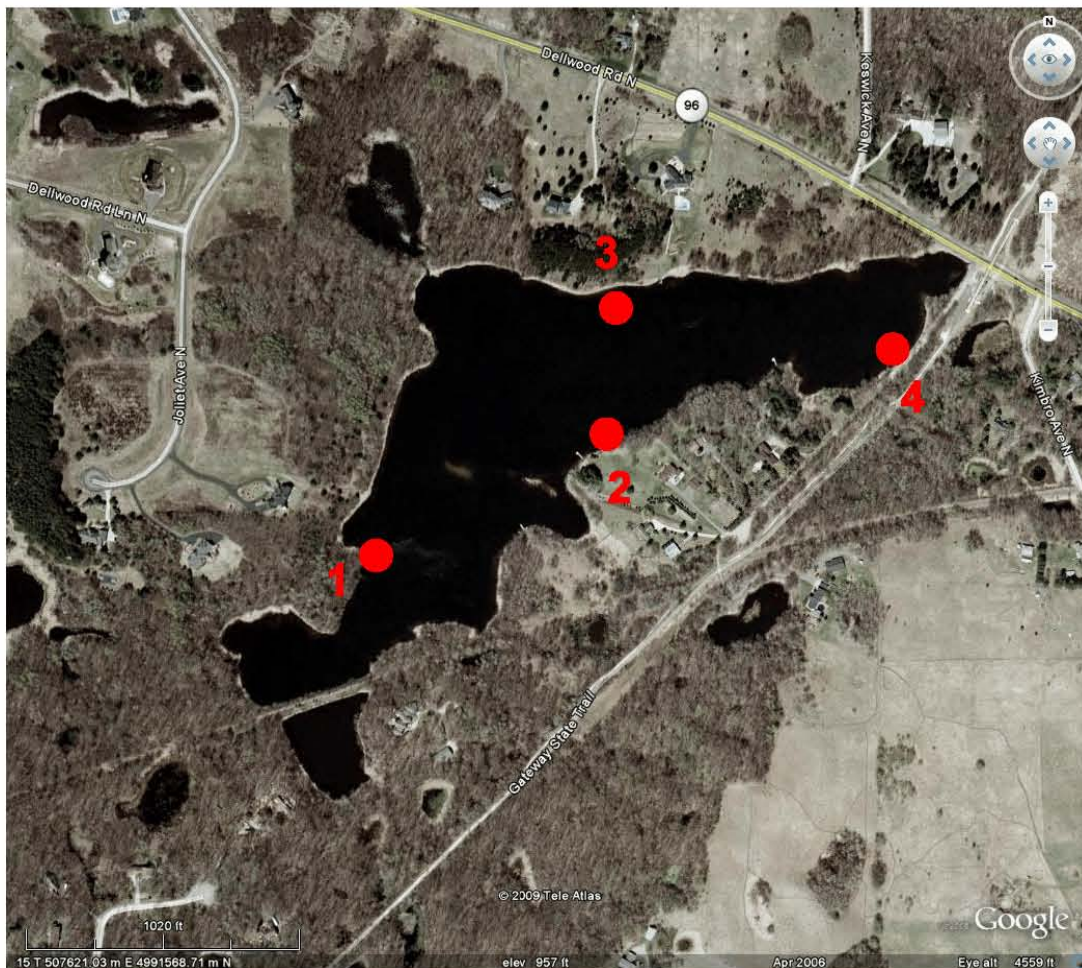
Figure 1. Map of trapnet sets.

Four standard trapnets were used for two days for a total of eight lifts to survey fish in Lake Masterman. The trapnet was a MnDNR-style with a 4 x 6 feet square frame with two funnel mouth openings and 50-foot lead. Net mesh size was ½ inch (bar length). Four standard trap nets were set on Tuesday morning August 11, 2009. Four nets were fished for the following 2 days (August 12, 13). Trapnet locations are shown in Figure 1 and pictures of a typical trapnet are shown in Figure 2.

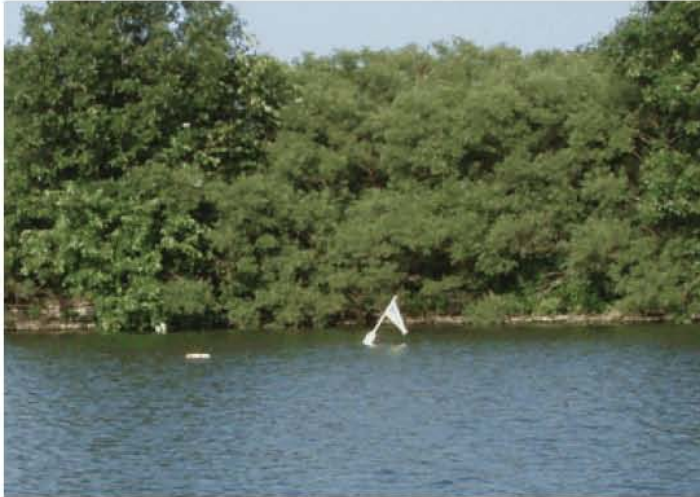
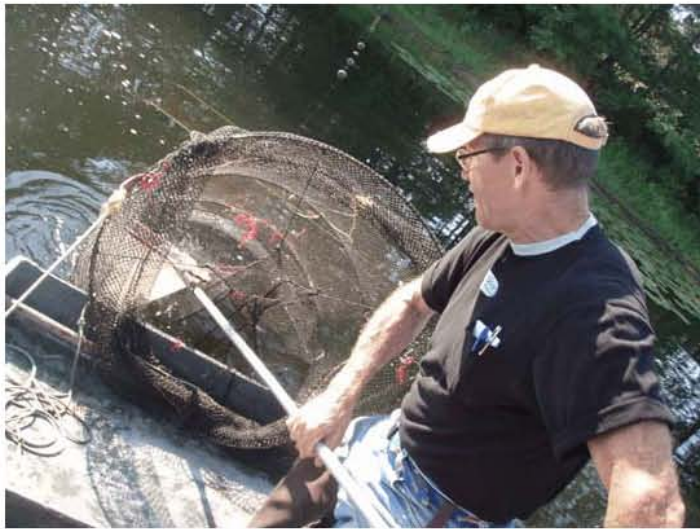
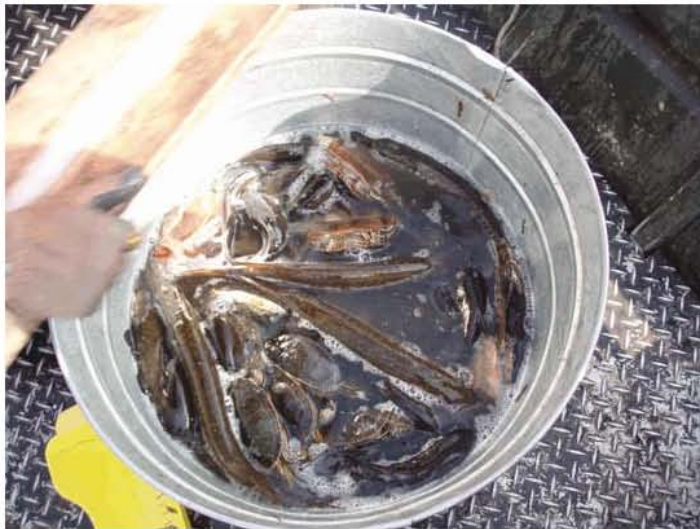
**Figure 2.**

**A trapnet is a live fish trap. Fish run into the 50-foot lead net and follow it back through a series of hoops with funnel mouths. Fish end up in the back hoop.**

**A handheld net is used to remove the fish from the back of the trapnet.**

**Fish are transferred to tubs, then they are counted and measured.**
