**Project Name** | Oak Glen Golf Course Streambank Repair Project**Date** | 02/3/2026**To / Contact info** | BCWD Board of Managers**Cc / Contact info** | Karen Kill, District Administrator**From / Contact info** | Mike Majeski, Dan Mossing, P.E.**Regarding** | Project Background & Scope of Work

## Background

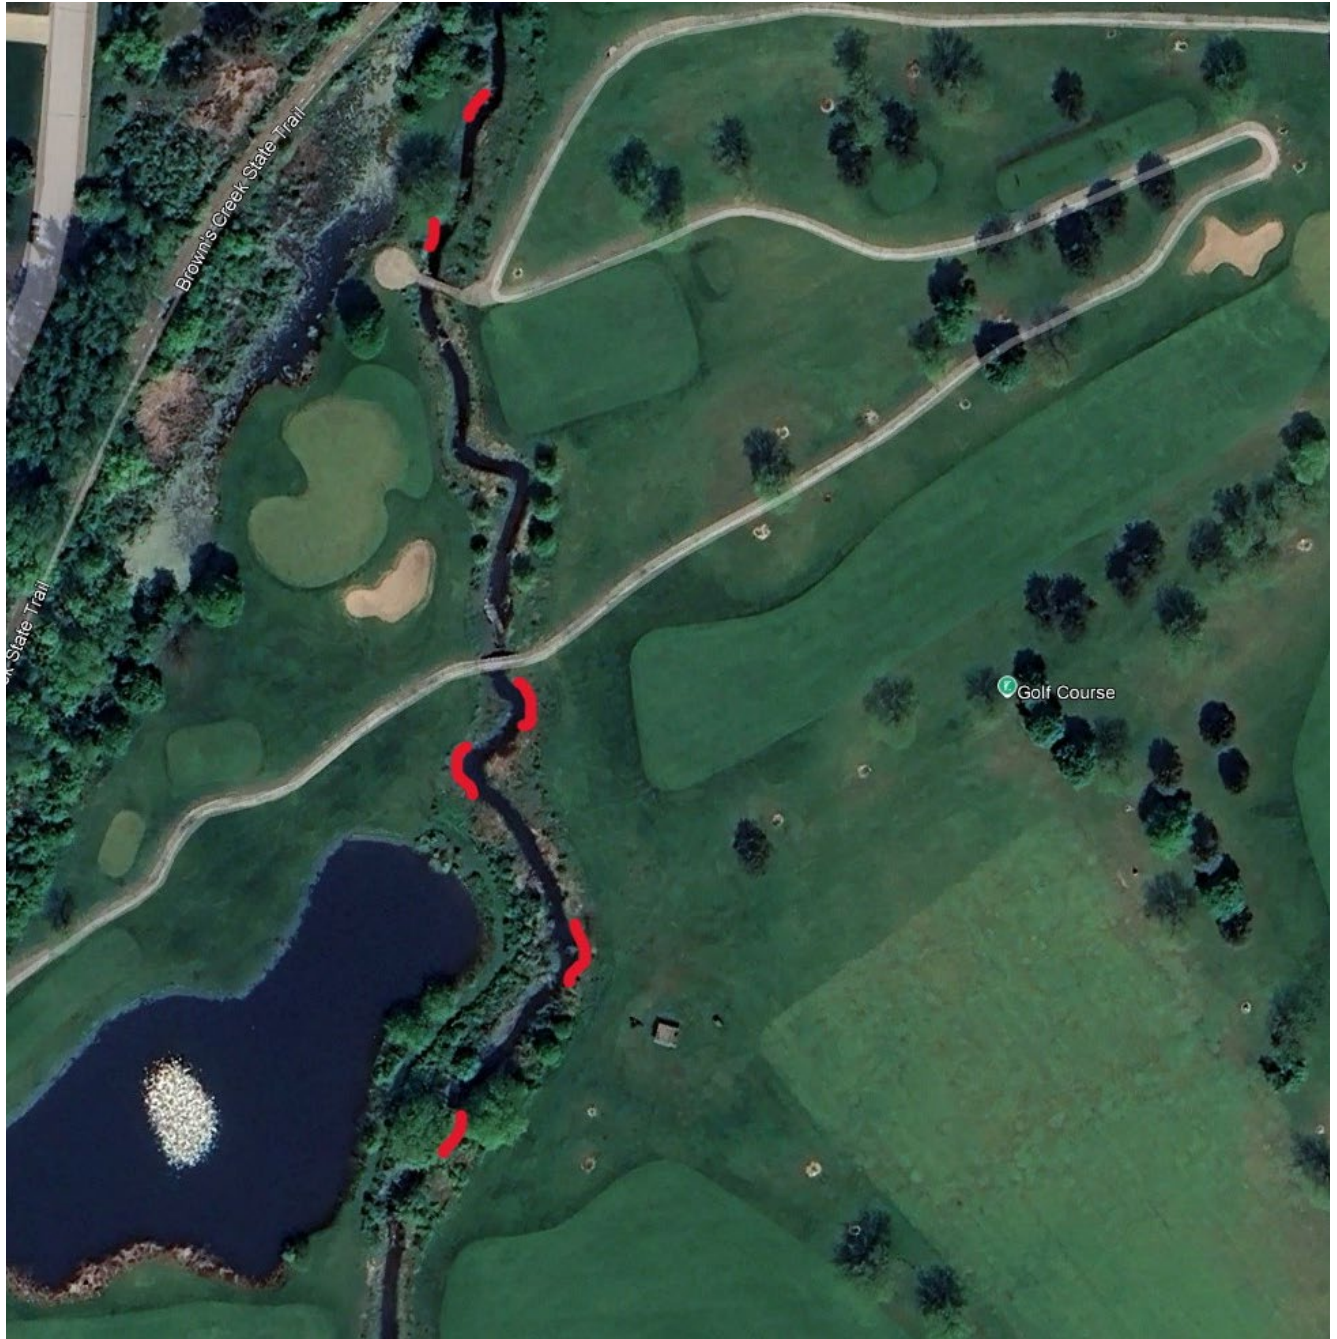
Figure 1. Proposed Brown's Creek bank repair sites (red lines) along the Oak Glen golf course.

During a creek inspection through the Oak Glen golf course in the fall of 2025, EOR identified six bank erosion sites downstream of McKusick Road (Figure 1). Following a field meeting with watershed, golf course, and DNR staff, EOR presented an approach to protect the eroding streambanks utilizing existing woody invasive species located within the creek buffer through the golf course. The banks would be protected using brush bundles comprised of hand-cut trunks and branches that would be inserted into the creek banks and anchored with wood stakes as needed. EOR has used this approach on other small-scale creek projects with success, and the DNR hydrologist approved of this method. In addition, this approach fits under the DNR's "no-permit-required criteria for bank or shoreline zone restoration work" and thus will not require a public waters work permit.

The streambanks to repair measure between 15-40 linear feet long, with the total length of bank repair estimated at 170 linear feet between all six sites. It was estimated that a total of 20 brush bundles will need to be installed for the project, and there is sufficient woody invasive material within the creek buffer to create the brush bundles. EOR will coordinate with WCD and golf course staff to harvest the woody material and preposition the brush within the buffer area. Installation of the brush bundles will be completed in the spring of 2026 after the DNR's winter stream work exclusion dates end (September 1 – April 1).
