Project Name | Long Lake Tributary – Degradation
To | Brown's Creek Watershed District
CC | Karen Kill, District Administrator
From | Kevin Biehn
Regarding | Board Update & Recommendation

Date | Jun 30, 2015

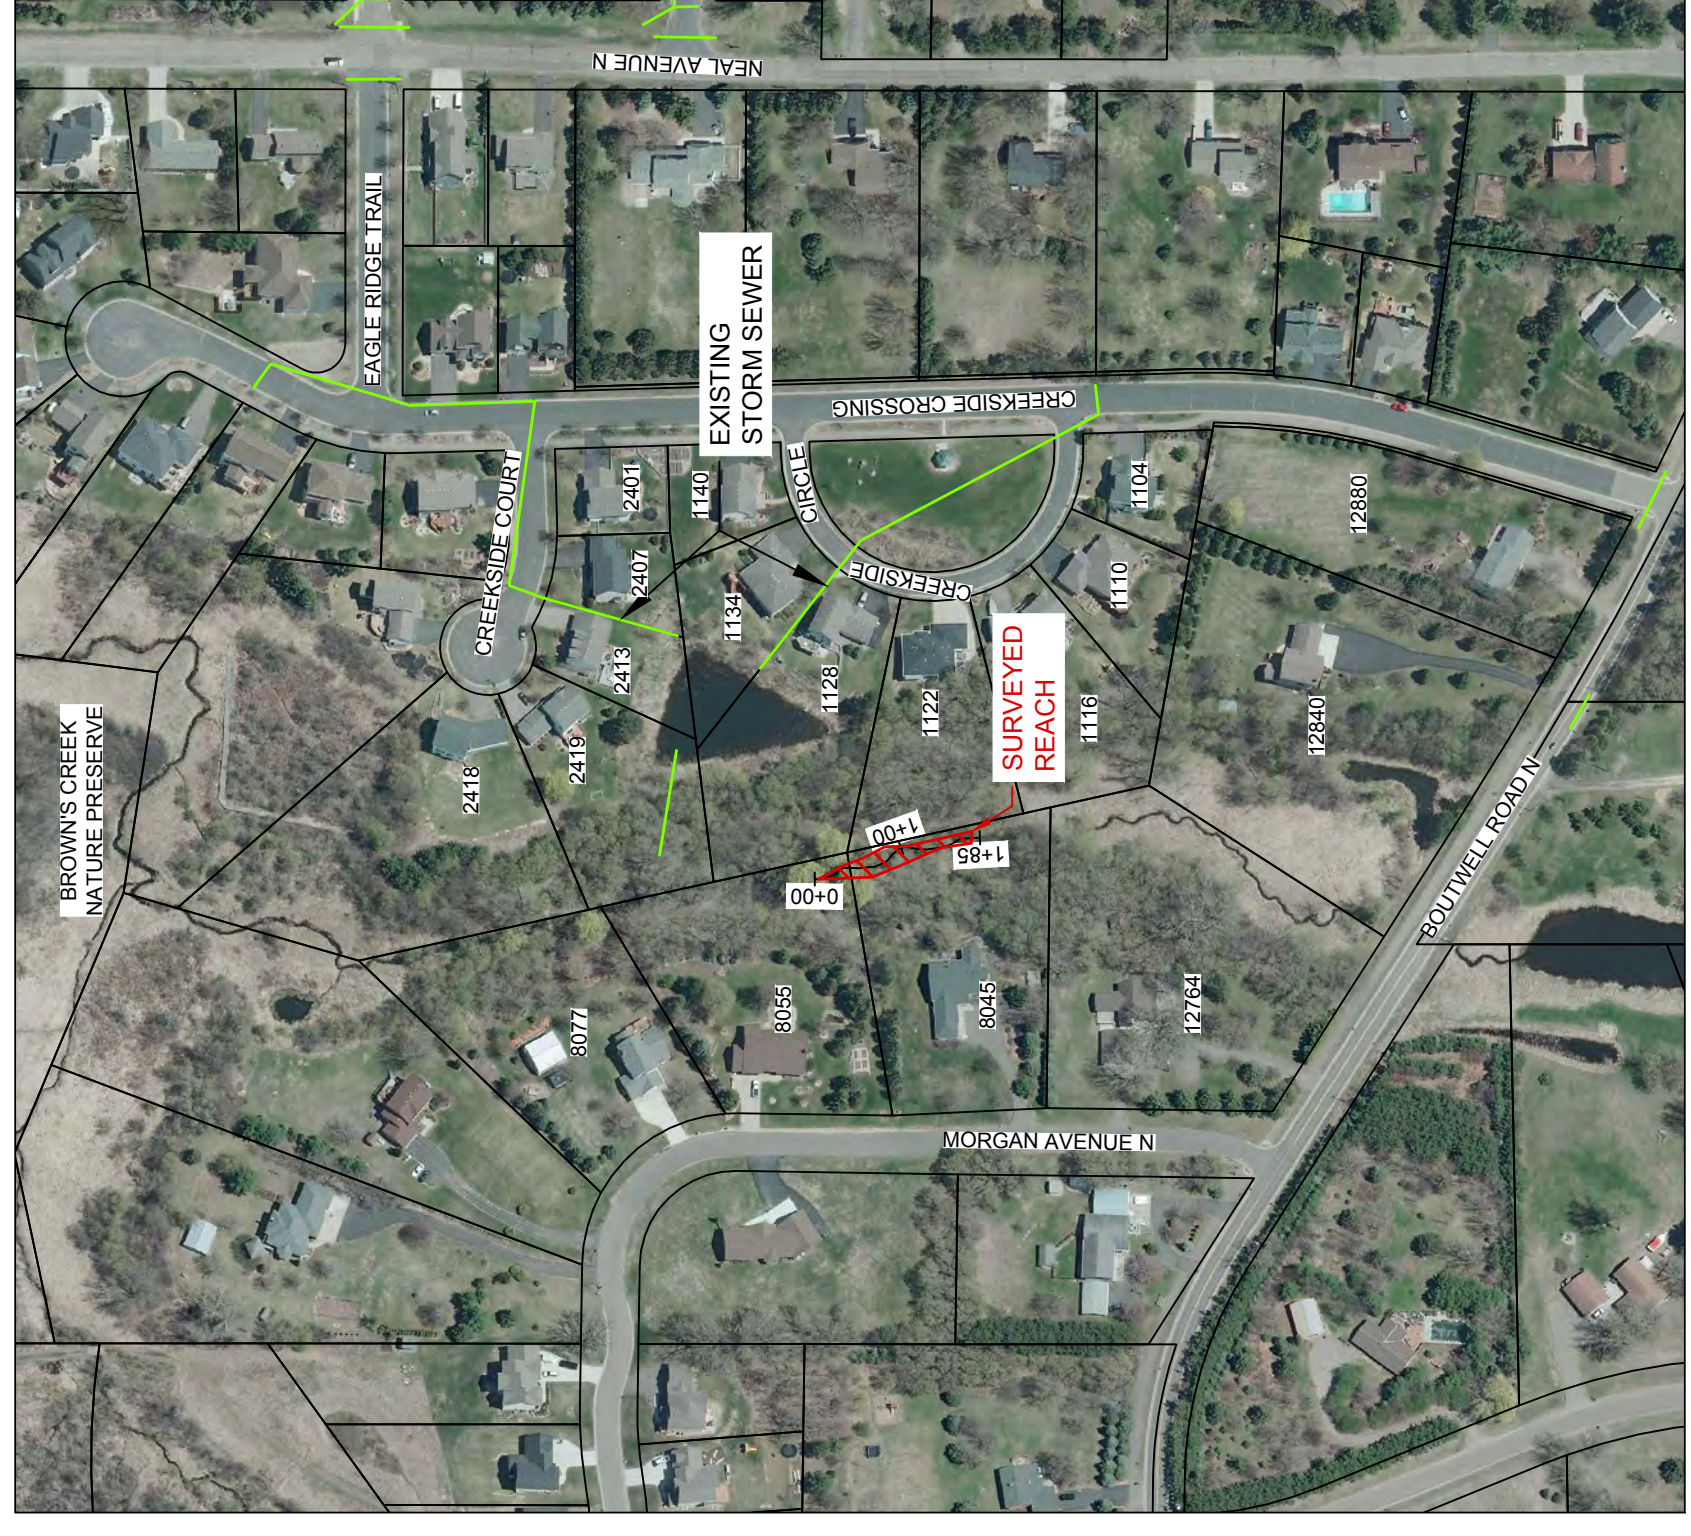
A head cut and stream channel incision were identified and surveyed (6/6/2013) via the aforementioned study. This survey serves as reference point to which future survey(s) can be compared against, providing an estimated rate of progression and associated sediment and nutrient contributions.

***Channel incision**, which is frequently associated with head cuts, is a process of channel adjustment by which the stream bed cuts into and ultimately establishes a lower bed elevation (Figure 2). The lowering bed elevation frequently separates the stream from its floodplain, which in turn results in higher channel erosivity. Channel incision is also frequently referred to as channel degradation.*

There are two primary issues associated with the identified stream degradation. The first is the increased sediment supply associated with the channel incision. Over the ~17 months between the surveys (6/6/2013 to 11/12/2014) an estimated 22 cubic yards of soil was eroded within the vicinity of the head cut and this volume of soil translates into ~24 pounds of phosphorus. While this tributary does not drain to Brown's Creek (as it is diverted to Lake McKusick), it equates to ~2.3% of Brown's Creek annual sediment load. McKusick Lake, which was impaired for aquatic recreation (pollutant or stressor was identified as excess nutrients) has since been de-listed (in 2012) due to the implementation of various watershed projects which have reduced stormwater runoff to the lake. While there would be a nutrient load associated with the annual sediment load it is safe to assume that this sediment load would deposit within the drainage path (including the wetlands upstream of the Diversion Structure) before making its way to McKusick Lake.

Option #2 would likely be constructed by imported rock within the area of the active head cut. The grade control structure(s) would be intended to halt further incision and would mitigate some of the damage upstream of the structure, but would not address downstream instabilities. Option #3 would invigorate understory plant growth, with the intent of stabilizing the tributary via a predictable stream
