Brown's Creek Restoration

Clean Water Funds: 2013

CWF13-207 - Clean Water Assistance

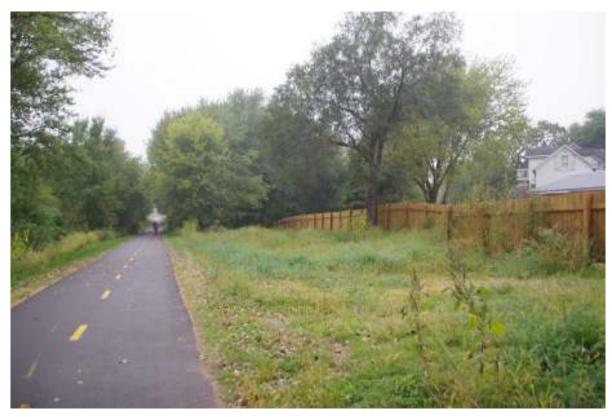
September 2015 - Brown's Creek water quality improvement project: site of an underground HDPE Water Quality Unit with associated inlet and outlet pipes and manhole structures within the DNR Trails Right-of-Way for sediment capture off of parking and drive lanes from Countryside Auto before entering an impaired trout stream.

Brown's Creek Watershed District, the MN DNR Trails and Countryside Auto Repair partnered to achieve significant thermal and sediment reductions in the biologically impaired Brown's Creek by installing an underground HDPE Water Quality Unit with associated inlet and outlet pipes and manhole structures within the DNR Trails Right-of-Way for sediment capture off of parking and drive lanes. The entire project site is intensely utilized, previously drained untreated water to Brown's Creek, and is located on the Brown's Creek State Trail. This project was identified as a high priority in the Brown's Creek TMDL Implementation Plan.
